#### B.4.4 WTC 5 Column-tree Shear Connections

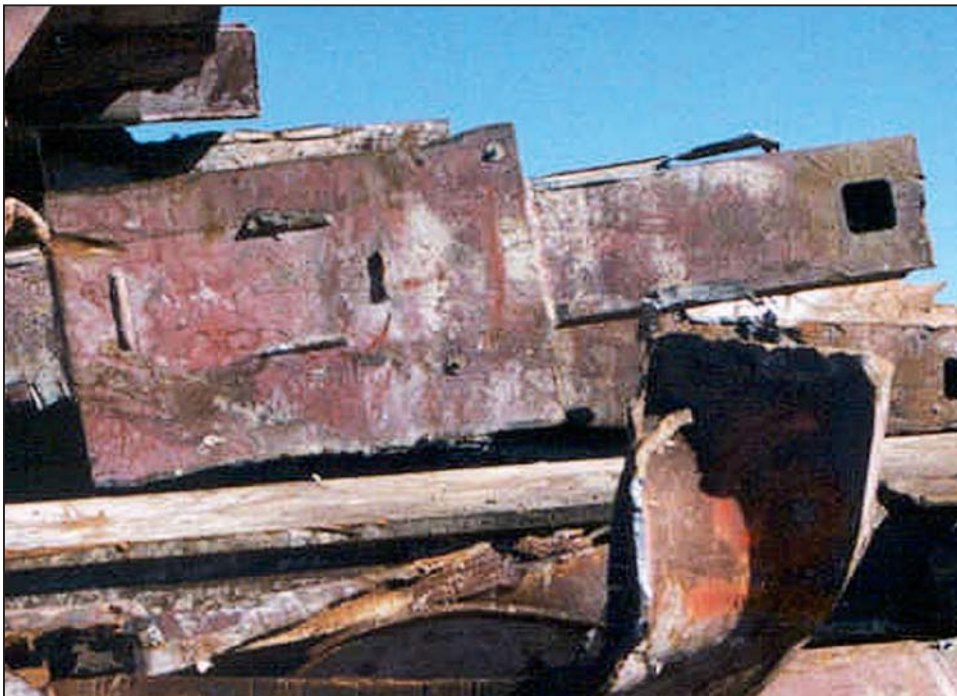
Many of the bearing seat brackets and the damper angle connections on the column/spandrel beam plate were completely sheared off. Only the weld segments remained on face of the column/spandrel beam plate (Figure B-11). This mode of failure appears to be due to excessive vertical overloads on the floor system. This is in contrast with the failure mode exhibited in Figure B-9 where the bearing seat bracket has pulled away from the column/spandrel plate, after fracture of the top chord gusset plate.

*Figure B-11  
Shear failure of floor truss  
connections from column/  
spandrel plate.*
