# C *Limited Metallurgical Examination*

## C.1 Introduction

## C.2 Sample 1 (From WTC 7)

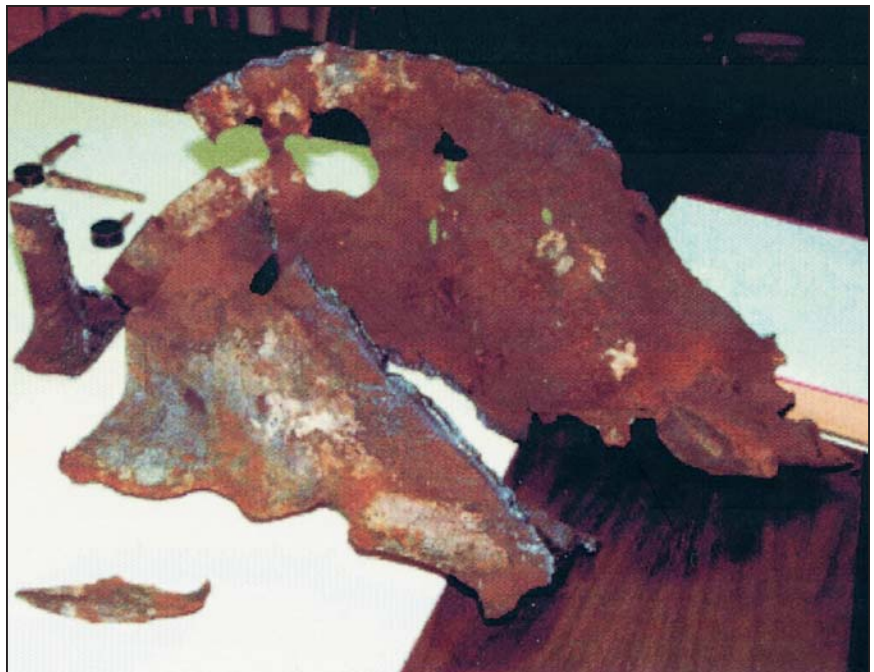
Several regions in the section of the beam shown in Figures C-1 and C-2 were examined to determine microstructural changes that occurred in the A36 structural steel as a result of the events of September 11, 2001, and the subsequent fires. Although the exact location of this beam in the building was not known, the severe erosion found in several beams warranted further consideration. In this preliminary study, optical and scanning electron metallography techniques were used to examine the most severely eroded regions as exemplified in the metallurgical mount shown in Figure C-3. Evidence of a severe high temperature corrosion attack on the steel, including oxidation and sulfidation with subsequent intergranular melting, was readily visible in the near-surface microstructure. A liquid eutectic mixture containing primarily iron, oxygen, and sulfur formed during this hot corrosion attack on the steel. This sulfur-rich liquid penetrated preferentially down grain boundaries of the steel, severely weakening the

Figure C-1 Eroded A36 wide-flange beam.
