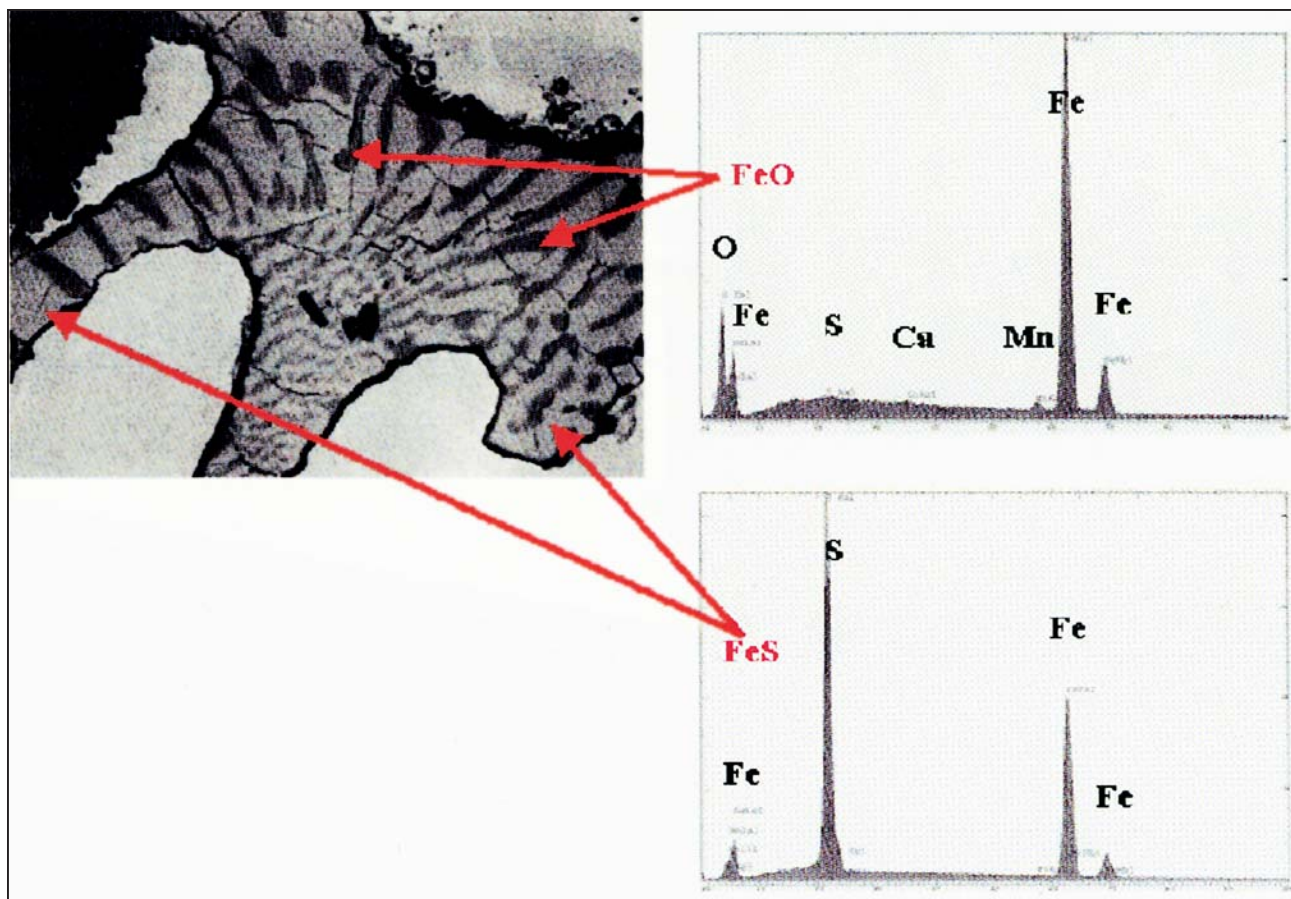
Figure C-8 Qualitative chemical analysis.

section of the steel that is unaffected by the hot corrosion. Figure C-7 illustrates the deep penetration of the liquid into the steel's structure. In order to identify the chemical composition of the eutectic, a qualitative chemical evaluation was done using energy dispersive X-ray analysis (EDX) of the eutectic reaction products. Figure C-8 illustrates the results of this analysis.

1. The thinning of the steel occurred by a high-temperature corrosion due to a combination of oxidation and sulfidation.
2. Heating of the steel into a hot corrosive environment approaching 1,000 °C (1,800 °F) results in the formation of a eutectic mixture of iron, oxygen, and sulfur that liquefied the steel.
3. The sulfidation attack of steel grain boundaries accelerated the corrosion and erosion of the steel.
