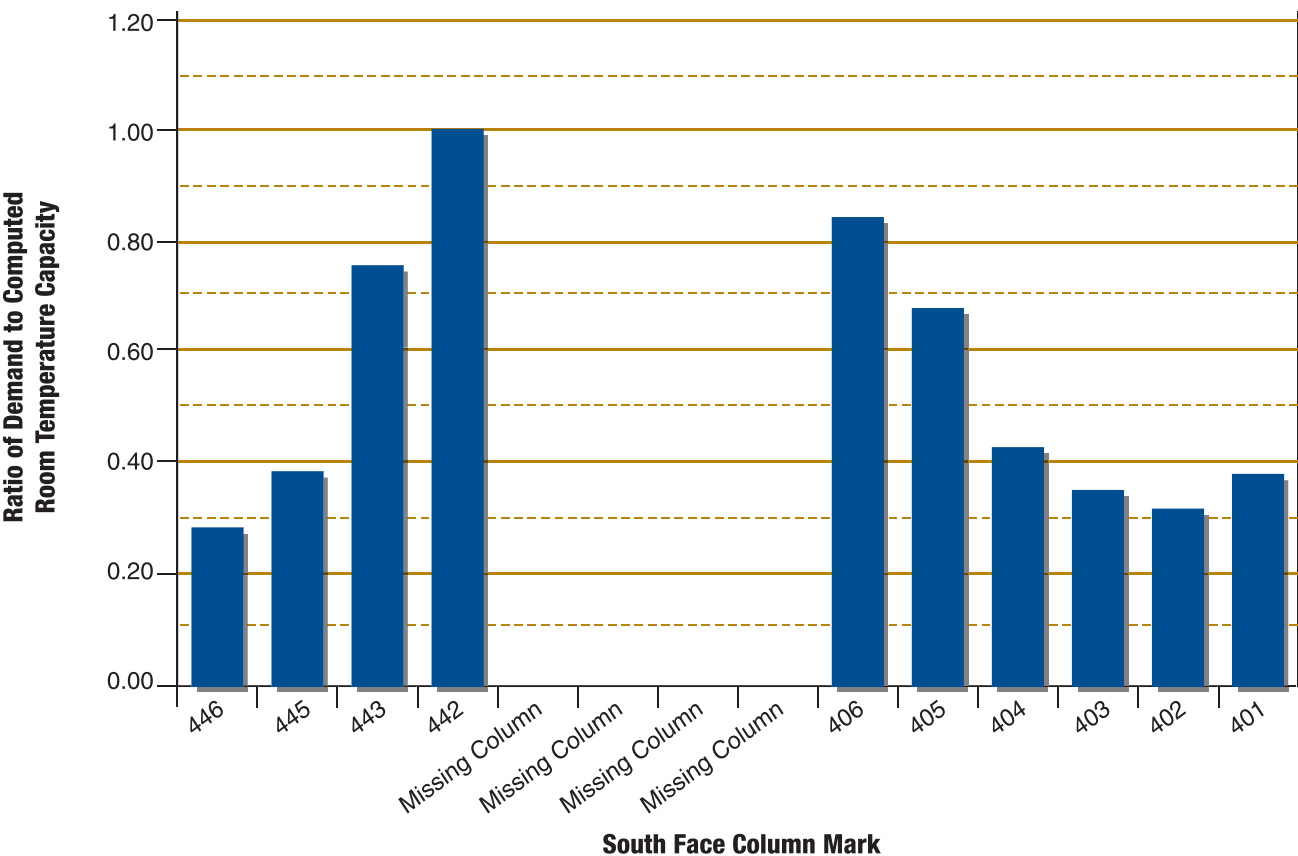
against collapse. However, this analysis does not consider damage to the building core, which was likely significant. Columns located further from the damage area are less severely impacted, and columns located only 20 feet away from the damaged area experience almost no increase in demand at all. These data are plotted in Figure 2-31.

The columns immediately above the damage area are predicted to act as tension members, transferring approximately 10 percent of the load initially carried by the damaged columns upward to the outrigger trusses, which, in turn, transfer this load back to the core columns. Not considering any damage to the core columns, utilization ratios on these elements are predicted to increase by about 20 percent at the 80th floor level. In upper stories, where the core columns were more lightly loaded, the increase in utilization ratio is substantially larger and may have approached a value of 1.0. These conditions would have been made more severe by damage to one or more core columns.

Figure 2-31 Plot of column utilization ratio at the 80th floor of WTC 2, viewed looking outward. (Conservatively assumes columns 407–411 and 440–441 to be missing.)
