### 3.3.2 Building Response

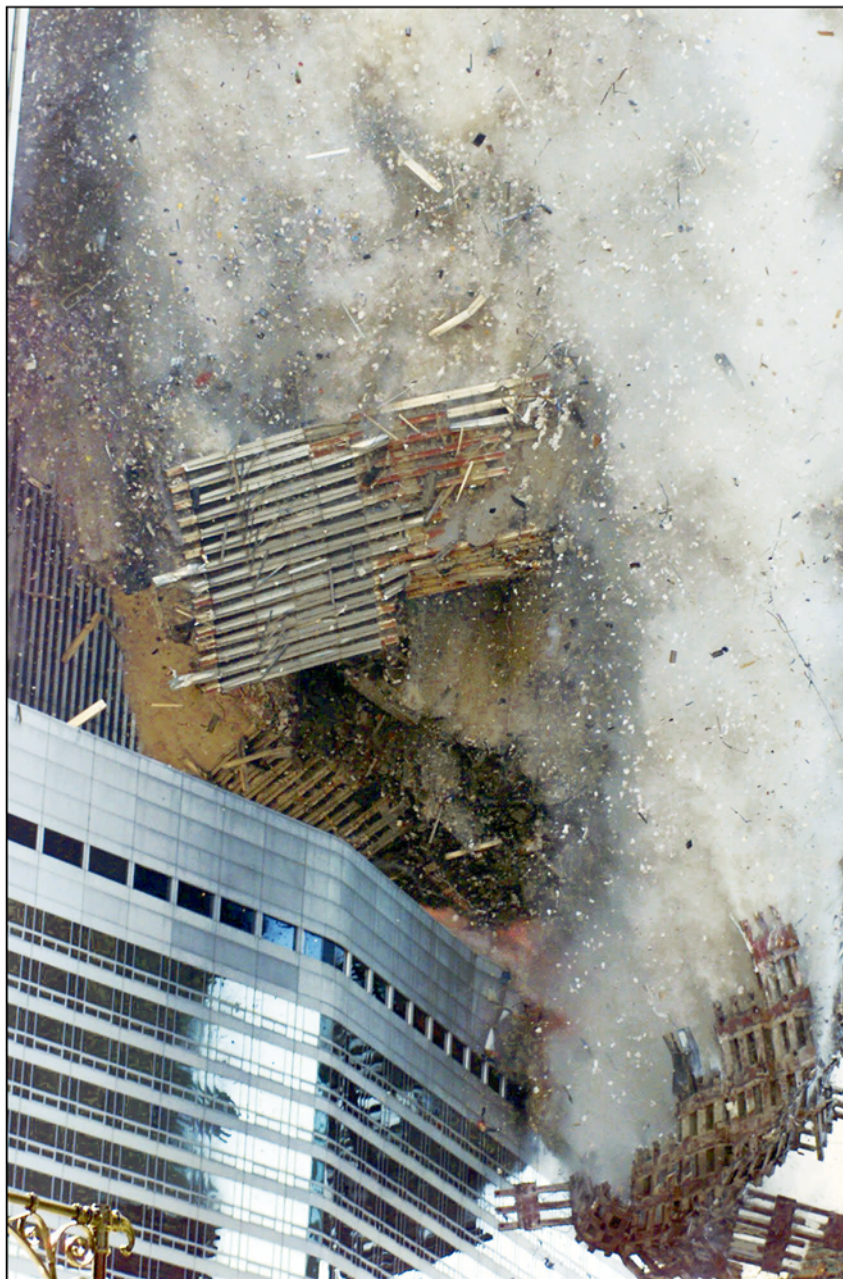
The response of WTC 3 to the September 11 events is complex and noteworthy. WTC 3 was subjected to two loading events. The first event involved the collapse of WTC 2, which stood immediately east of WTC 3. Due to its proximity to WTC 2, substantial amounts of debris fell directly on the roof of WTC 3. Figure 3-6 shows large portions of the prefabricated assemblies from WTC 2 falling on top of WTC 3.

*Figure 3-6  
Exterior columns from the collapse of WTC  
2 falling on the southern part of WTC 3.*
