## 4.3 Analysis of Building Performance

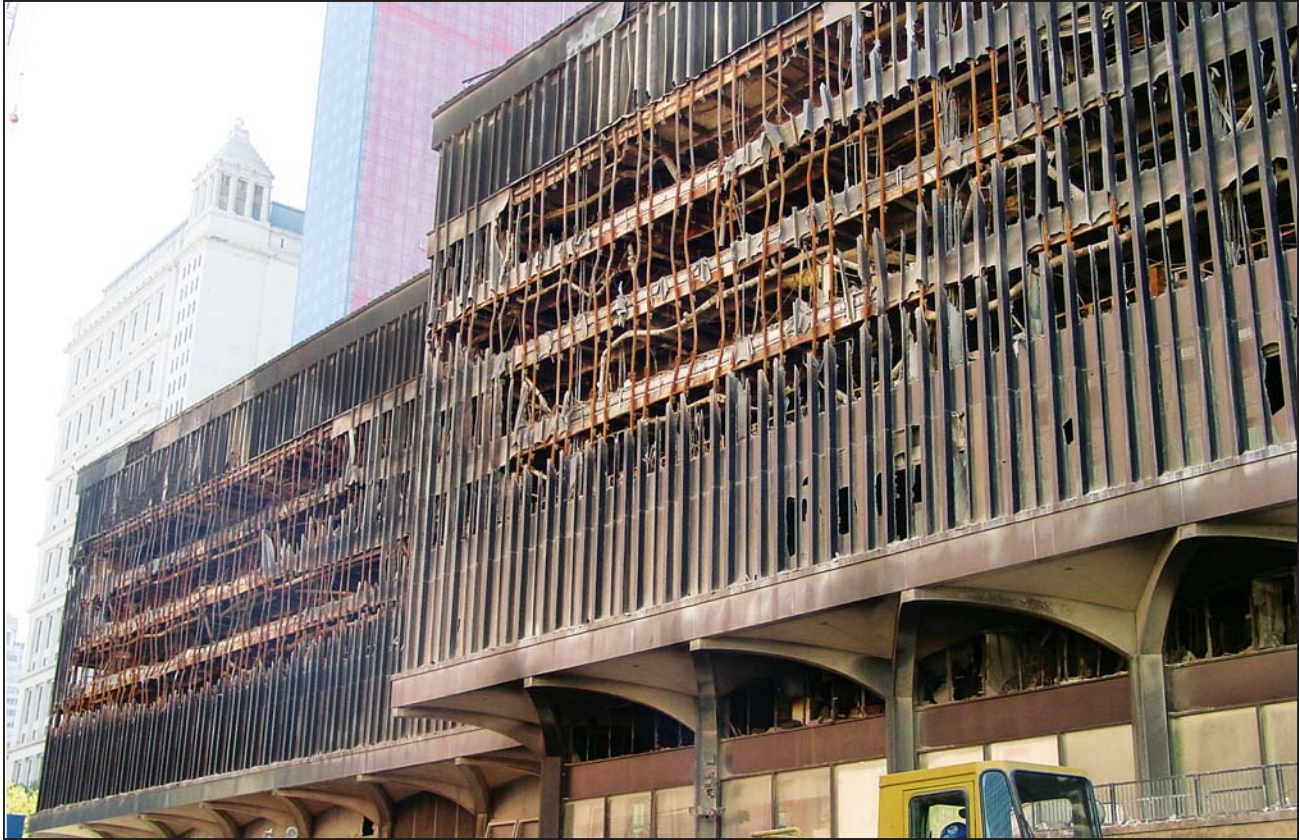
Figure 4-11 WTC 5 façade damage.

The debris from the towers caused damage to the outside wall steel framing of WTC 5, but this damage did not cause any additional collapse of the floors. In fact, the steel pipe façade supports (mullions) provided structural redundancy to the floor framing and redistributed some portion of the cantilevered floors to other levels.
