#### 4.3.2 WTC 5 - Local Collapse Mechanisms

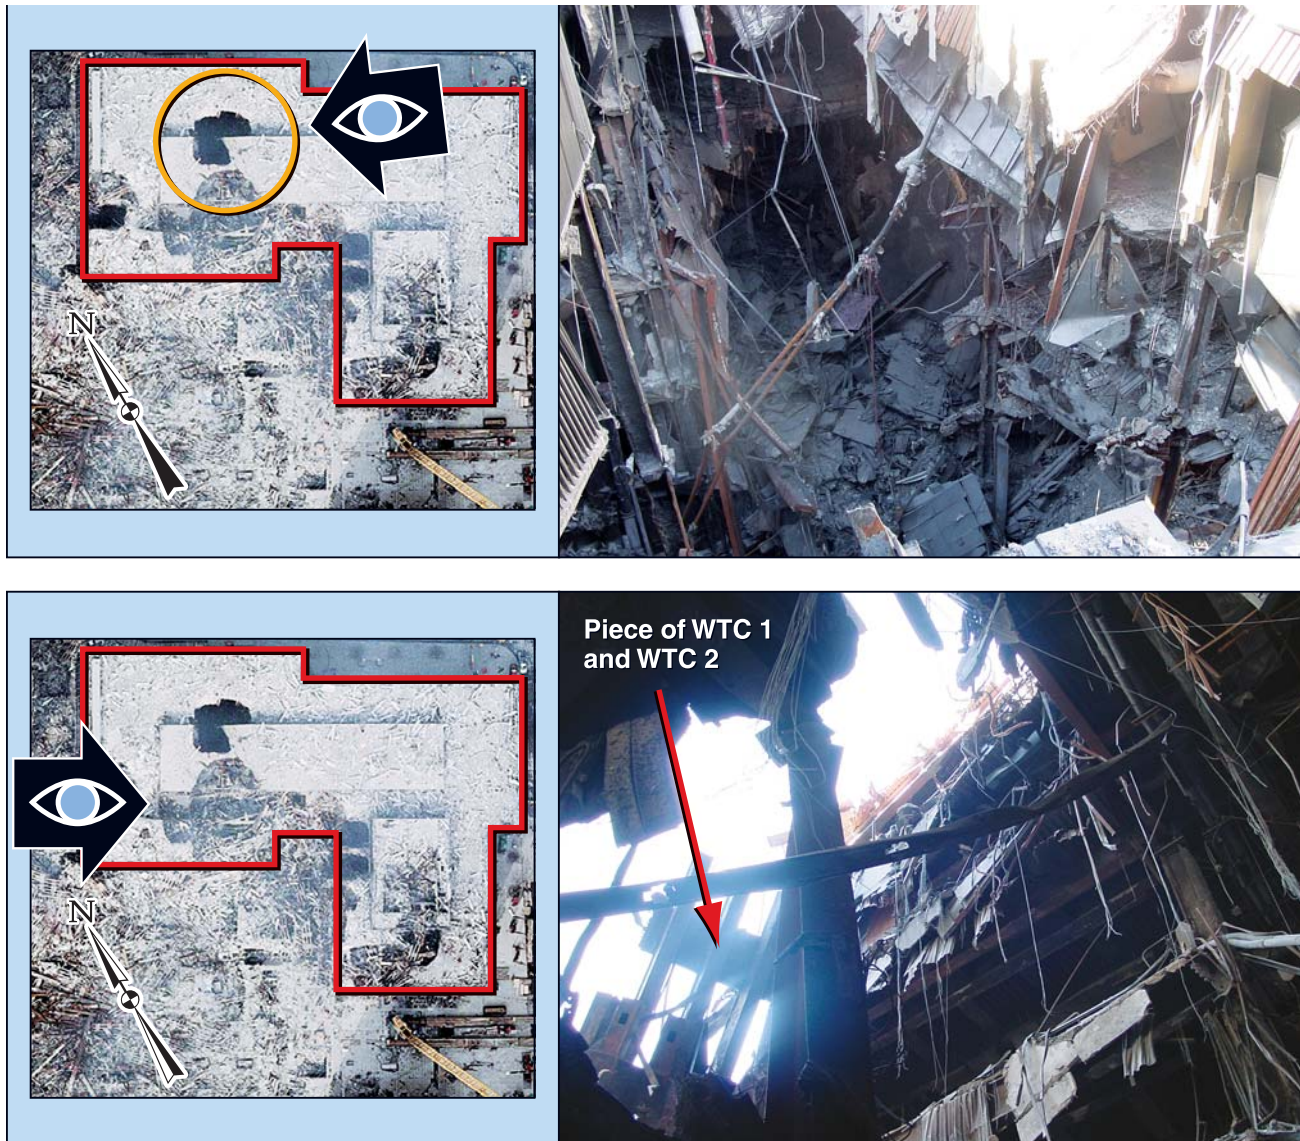
Figure 4-12 Impact damage to WTC 5 (continued).
