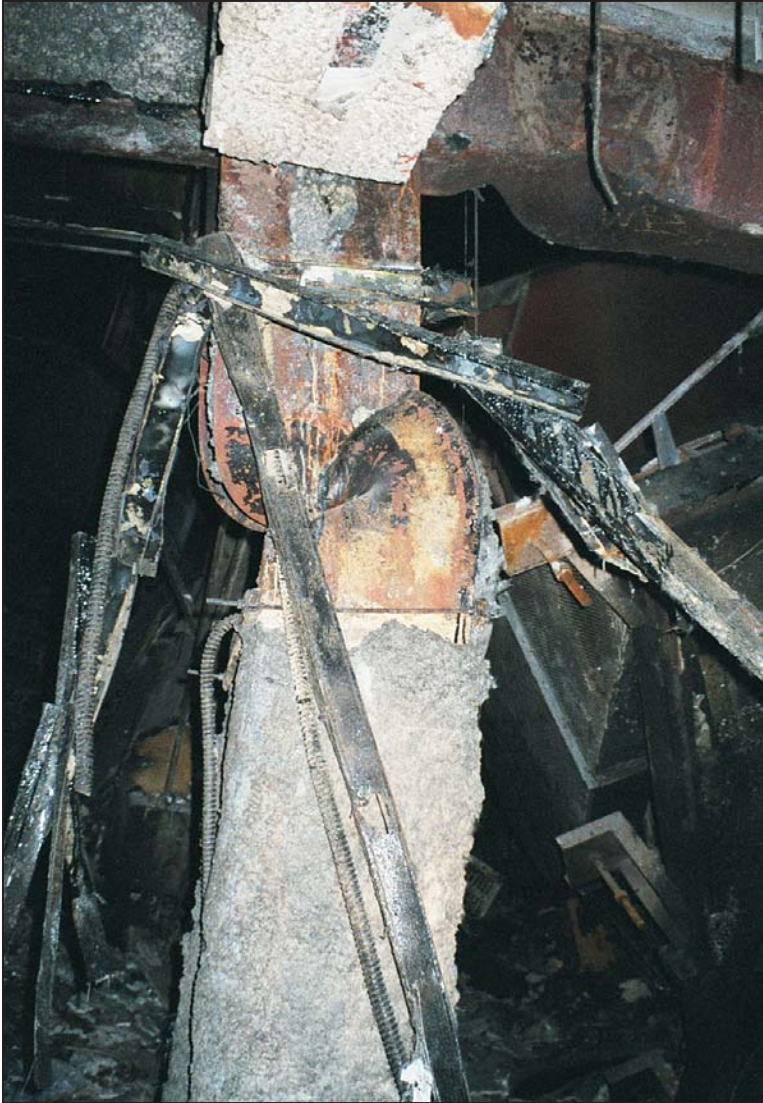
*Figure 4-17  
Buckled beam flange and column on the 8th floor  
of WTC 5 that was weakened by fire.*
