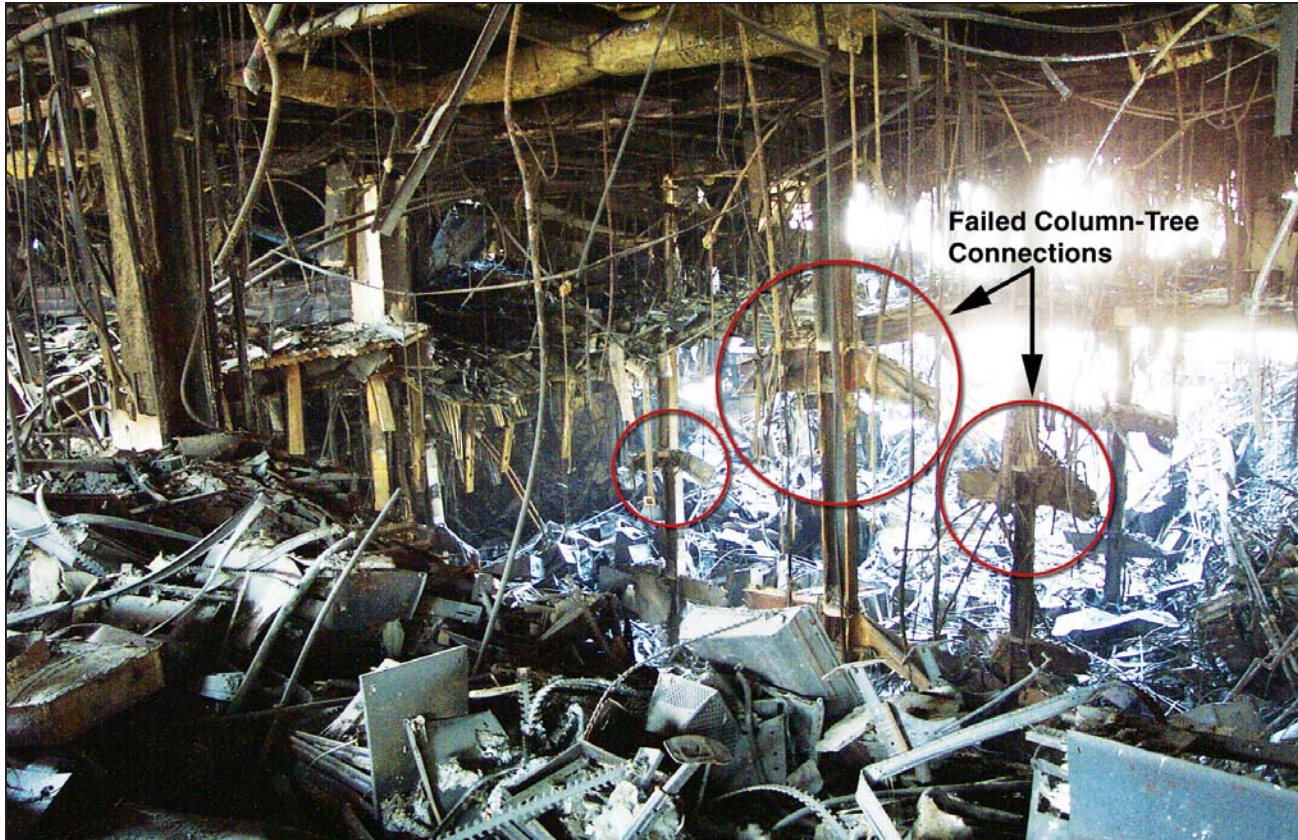
Figure 4-18 Internal collapsed area in WTC 5.

The steel generally behaved as expected given the fire conditions in WTC 5. Many beams developed catenary action as illustrated in Figure 4-14. Some columns buckled, as shown in Figure 4-17. The one exception is the limited internal structural collapse in WTC 5. The fire-induced failure that led to this collapse was unexpected. As in the rest of the building, the steel beams were expected to deflect significantly, yet carry the load. This was not the case where the beam connections failed. The failure most likely occurred during the heating of the structure because the columns remained straight and freestanding after the collapse.
