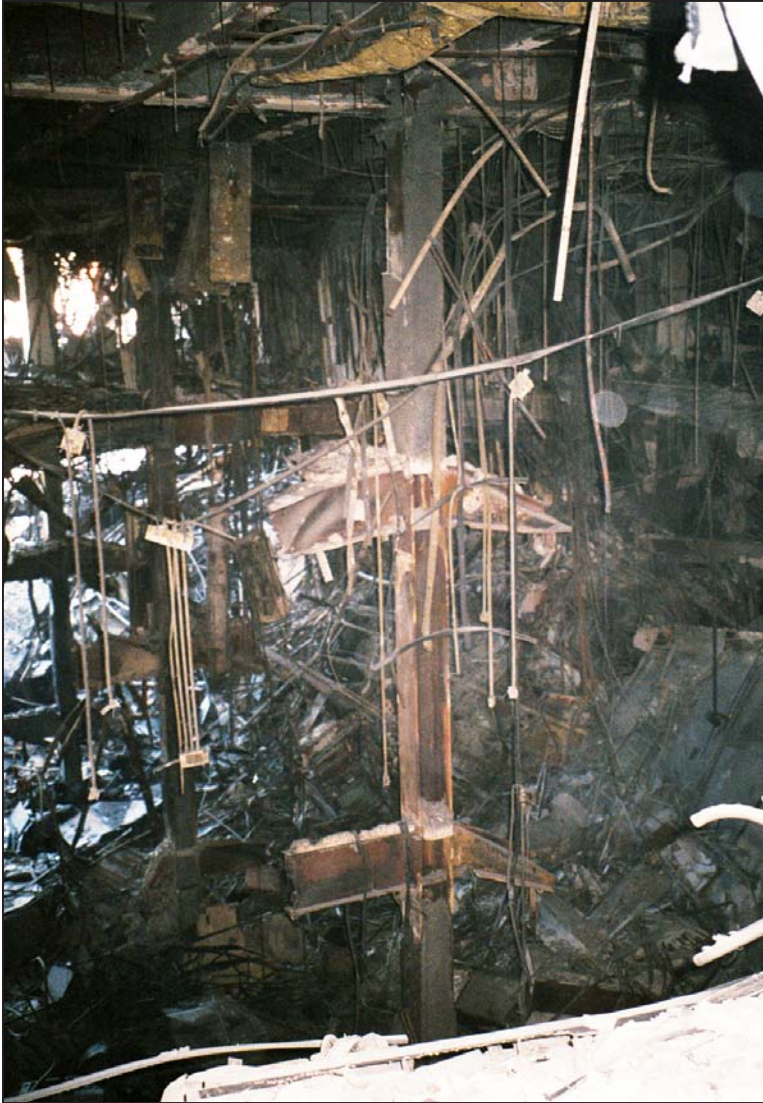
*Figure 4-19*  
*Internal collapsed area in WTC 5.*

The limited structural collapse in WTC 5 due to fire impact as described in Section 4.3.2 appeared to be caused by a combination of excessive shear loads and tensile forces acting on the simple shear connections of the infill beams. The existence of high shear loads was evident in many of the column tree beam stub cantilevers that formed diagonal tension field failure mechanisms in the cantilever webs, as seen in Figure 4-19.

The end bearing resistance of the beam web was less than the double shear strength of the high-strength bolts. An increased edge distance might have prevented this collapse by increasing the connections' tensile strength. The failure most likely began on the 8th floor and progressed downward, because the 9th floor did not collapse. The 4th floor and those below remained intact.
