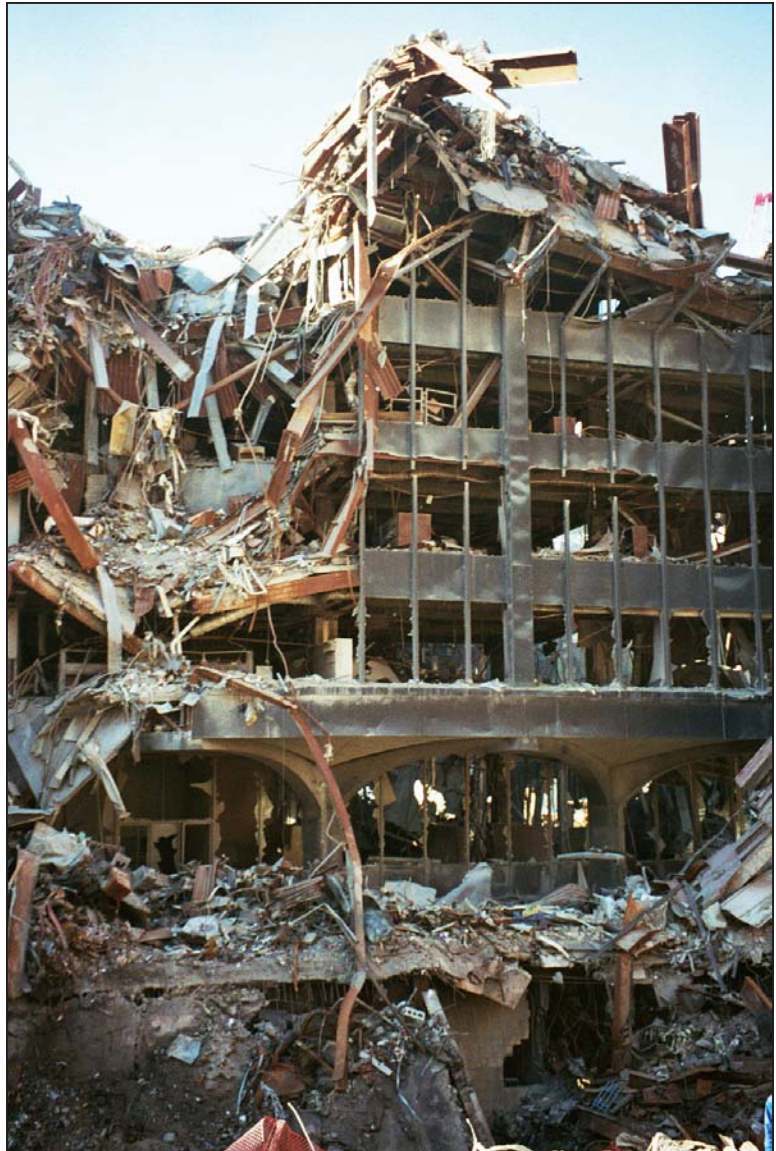
Figure 4-10 Impact damage to the exterior façade of WTC 6.
