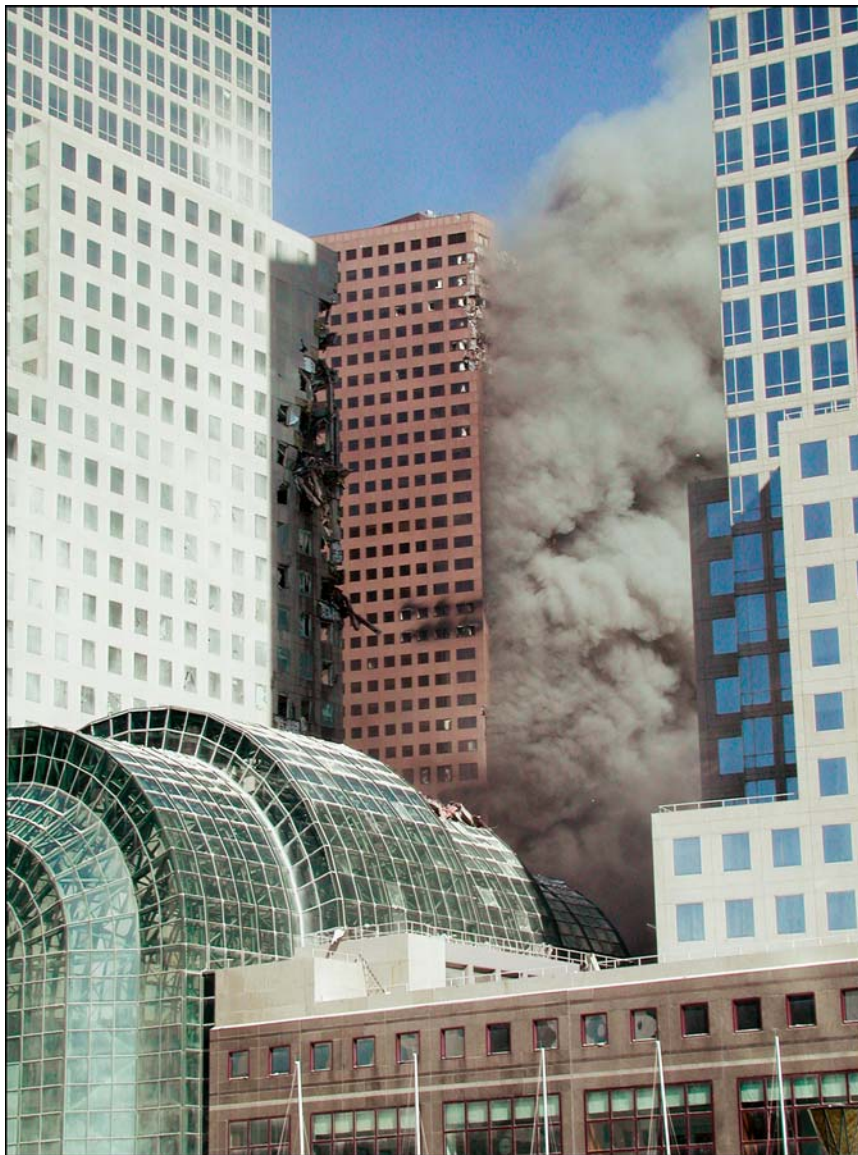
Figure 5-17, a photograph taken across from the World Financial Center (WFC), shows the west elevation and indicates damage at the southwest corner of WTC 7 at the 24th, 25th, and 39th through 46th floors.

*Figure 5-17  
Building damage to the southwest corner and smoke plume from south face of WTC 7, looking from the World Financial Plaza. Note damage to WFC 3 in the foreground.*
