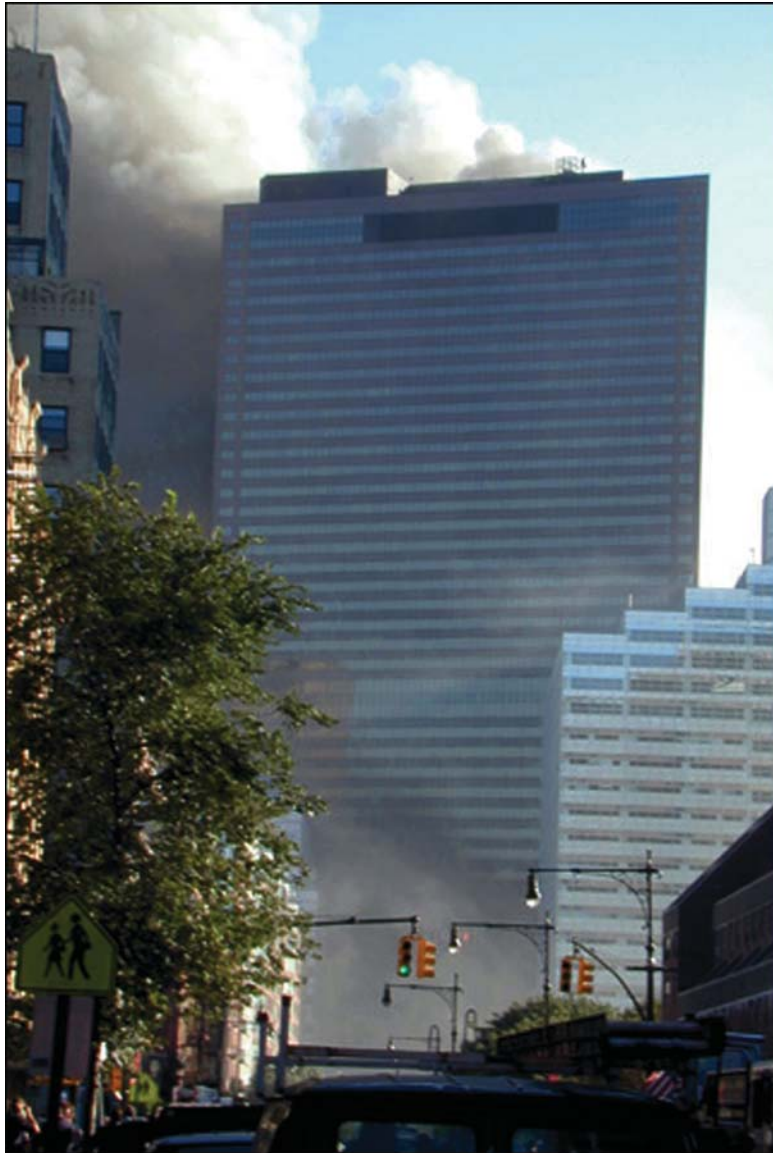
*Figure 5-20  
View from the north of WTC 7 with both  
mechanical penthouses intact.*
