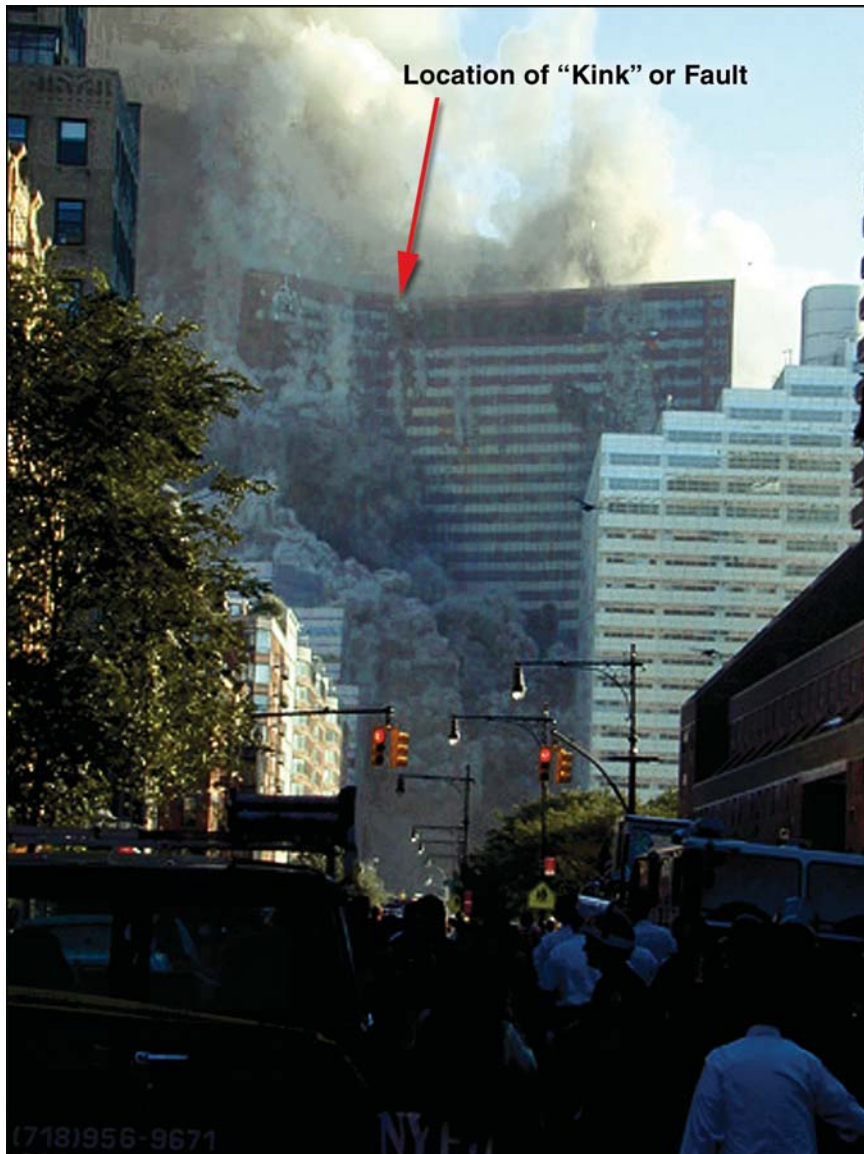
*Figure 5-23*  
View from the north of the “kink” or fault developing in WTC 7.
