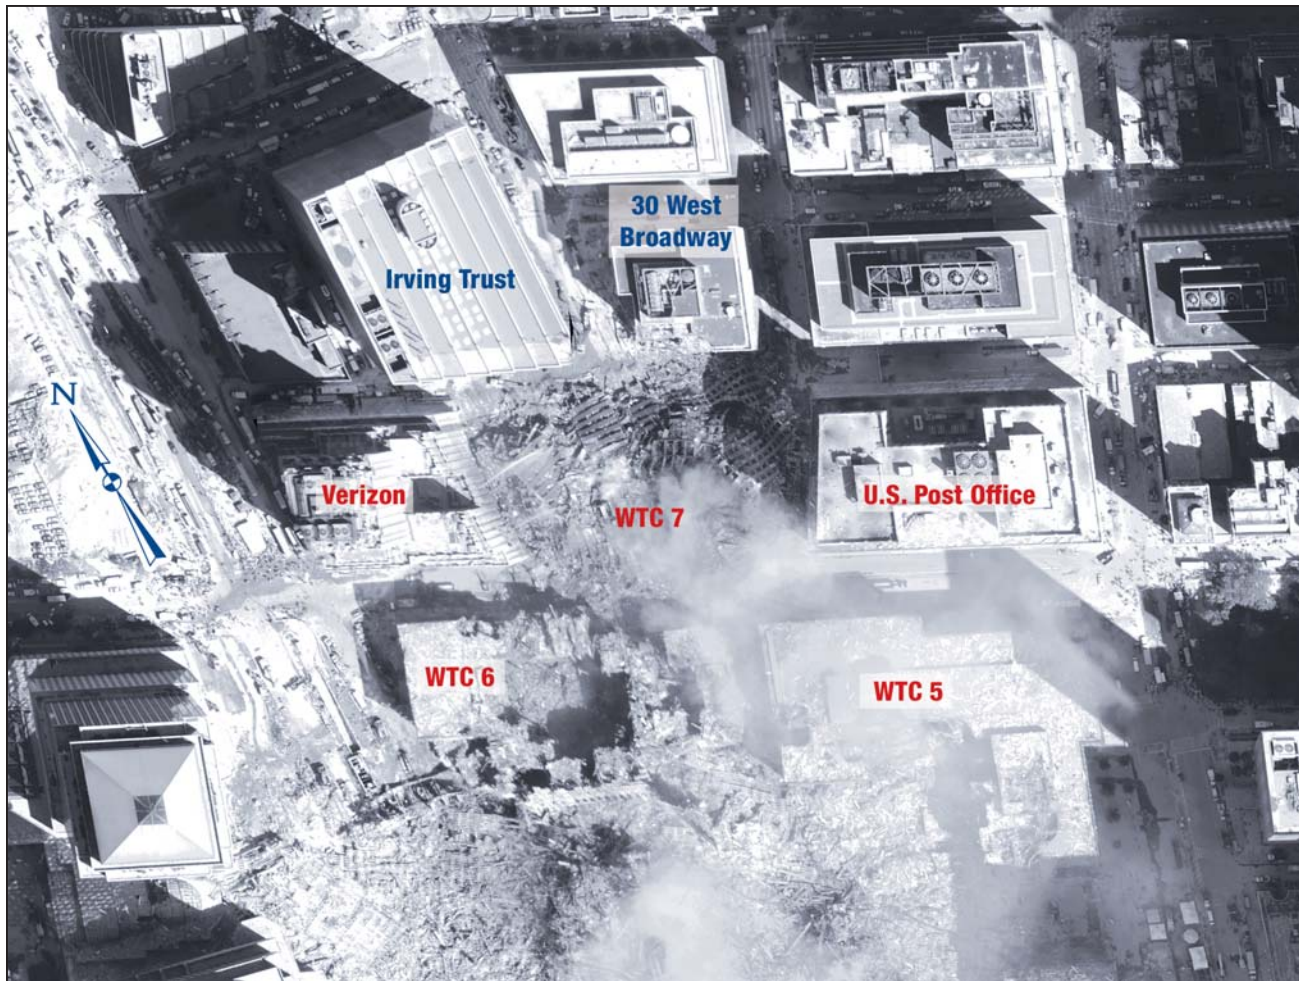
Figure 5-26 Debris generated after collapse of WTC 7.
