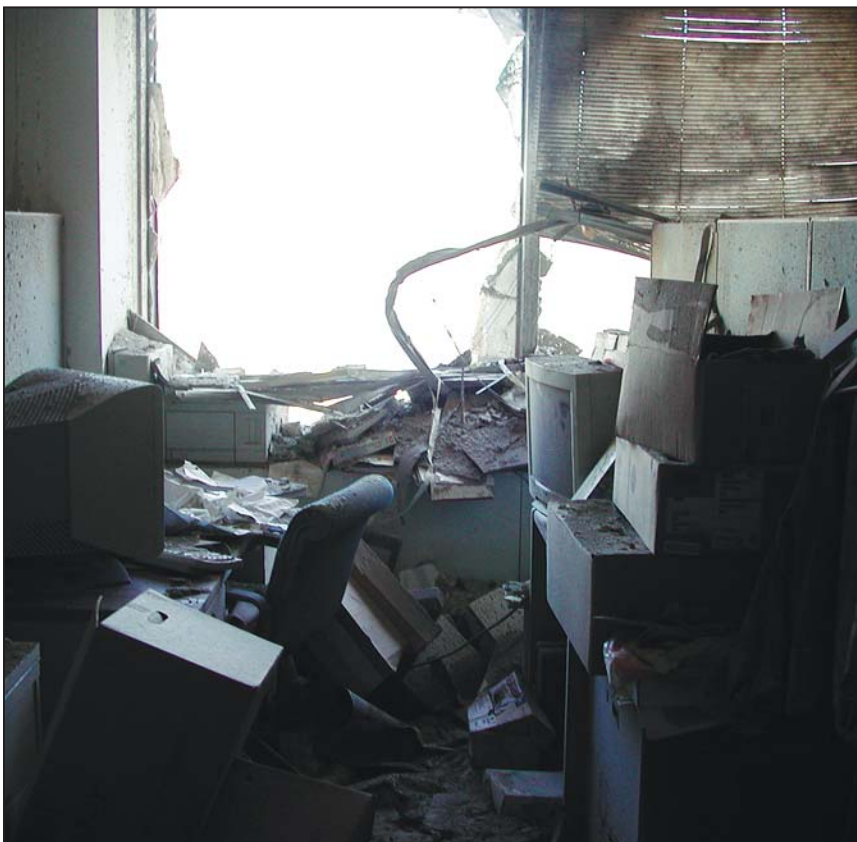
After the exterior glazing was penetrated by the debris, the dust cloud resulting from the collapse of the towers deposited a layer of dust an inch or more thick throughout the northern part of the building. The 2nd floor lobby area had extensive broken glass, general debris, and dust (Figure 6-11). Figure 6-12 shows a typical office near the collapsed area at the 8th floor.

*Figure 6-12  
Office at the north side of the 8th floor.*
