### 6.3 Structural Damage Description

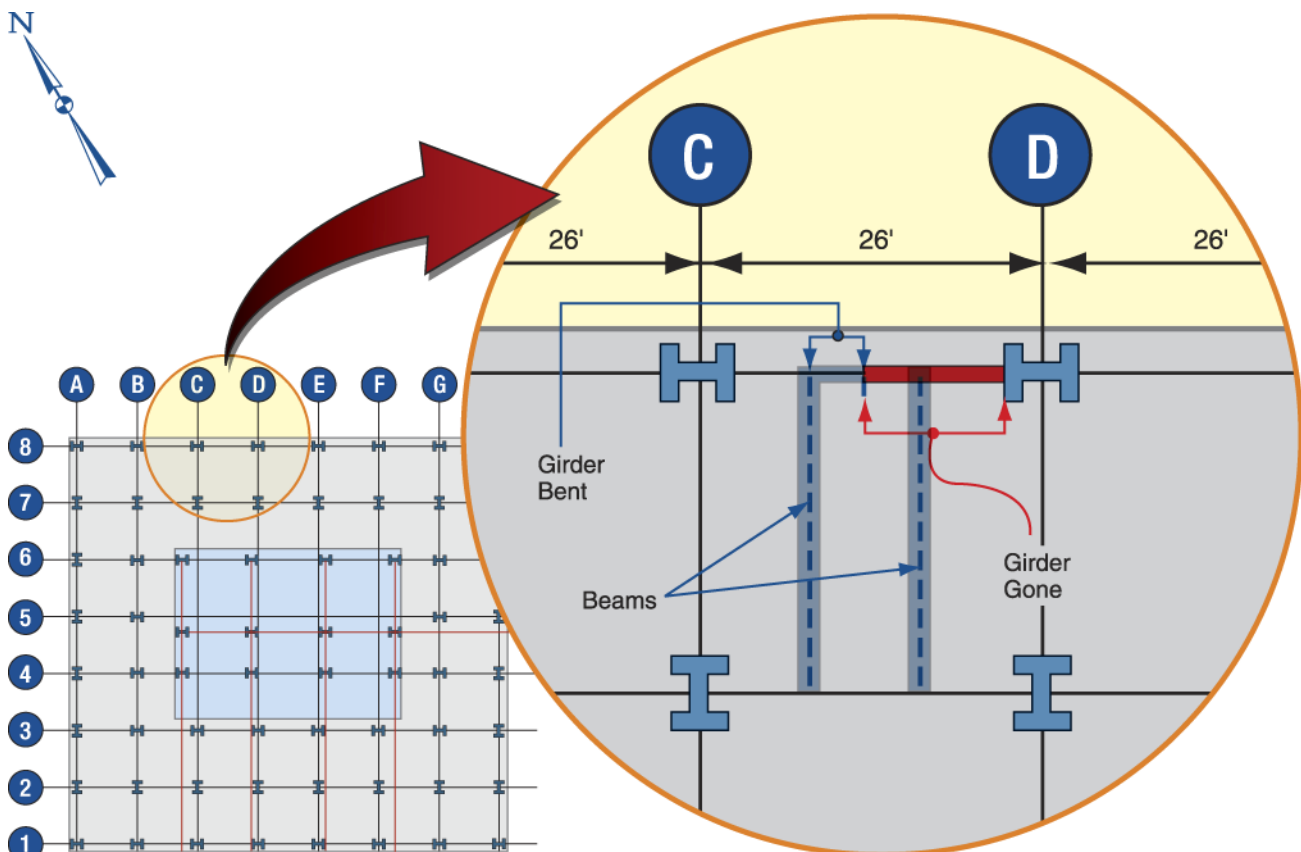
It appears that the direction of motion of the falling debris from WTC 2 was steeply angled down and to the east-southeast. As the falling debris smashed through the 23rd floor spandrel between column lines C and D, it and the debris it created at each floor continued to dive deeper into the building, causing more structural damage. Between the 19th and 22nd floors, the floor areas between column lines 7 and 8, and C and D were damaged or destroyed (Figure 6-5). The damage zone increased to include portions of the area between column lines D and E from the 18th floor down to the 9th floor (Figure 6-5).

Figure 6-4 Area of initial impact of debris at the 23rd floor.
