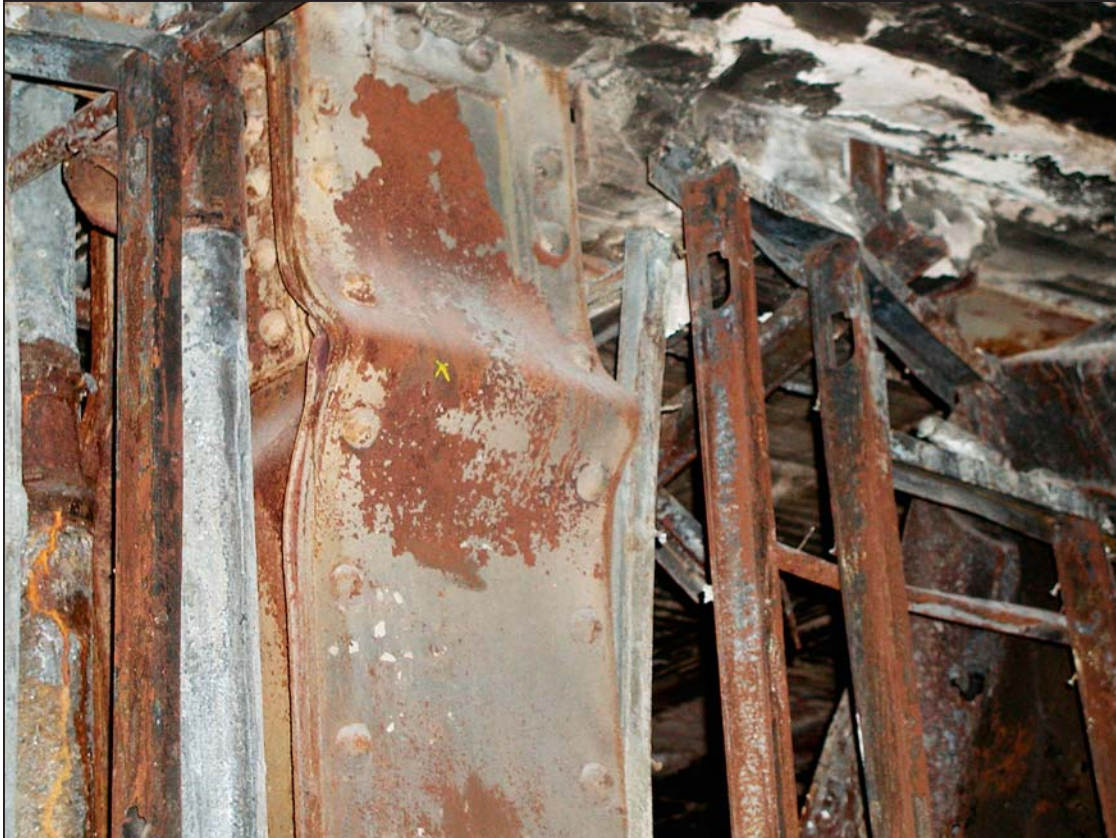
*Figure 7-17 Buckling damage at top of column on floor 23 of 90 West Street.*
