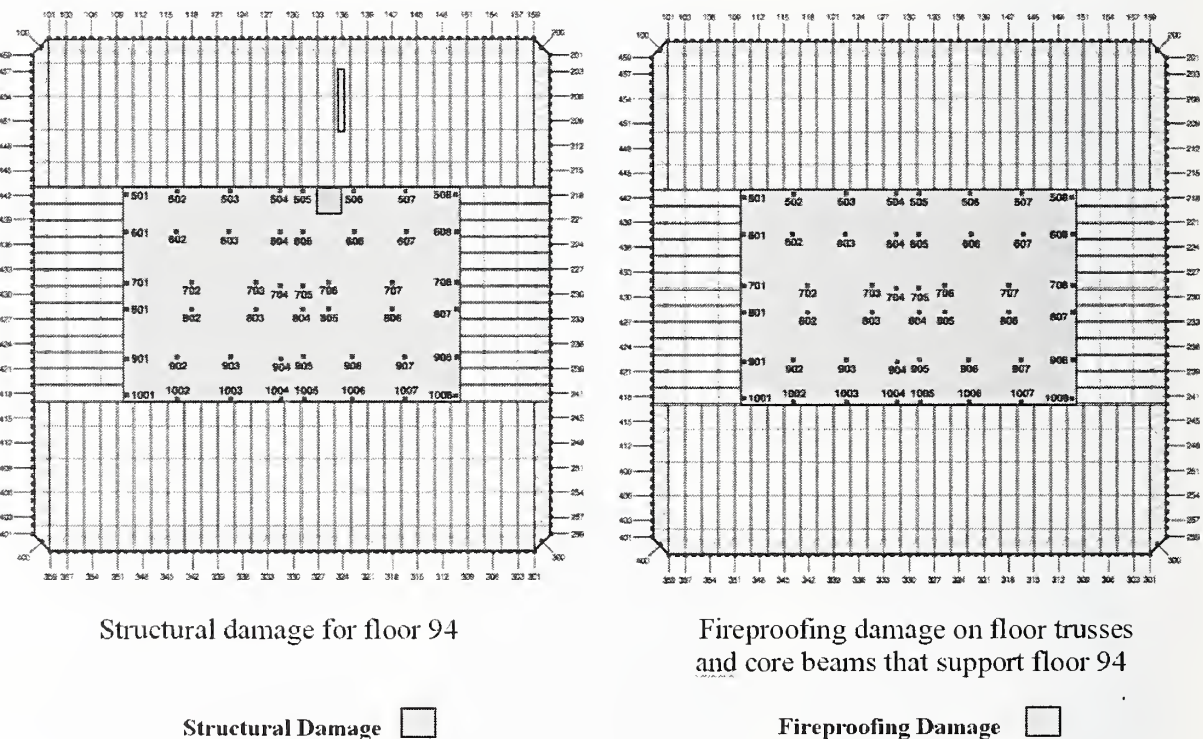
Figure 6–45 shows the structural and insulation damage to floor 94.<sup>1</sup>

**Figure 6–45. Structural and insulation damage to floor 94 of WTC 1, Case A.**

The trusses supporting the slab on the 94<sup>th</sup> floor, with their insulation intact, stayed relatively cool, heating no more than 150 °C during the course of the simulation. The thinly insulated core beams were covered with 0.5 in. insulation and as a result, the core beams were heated significantly at 1,800 s and
