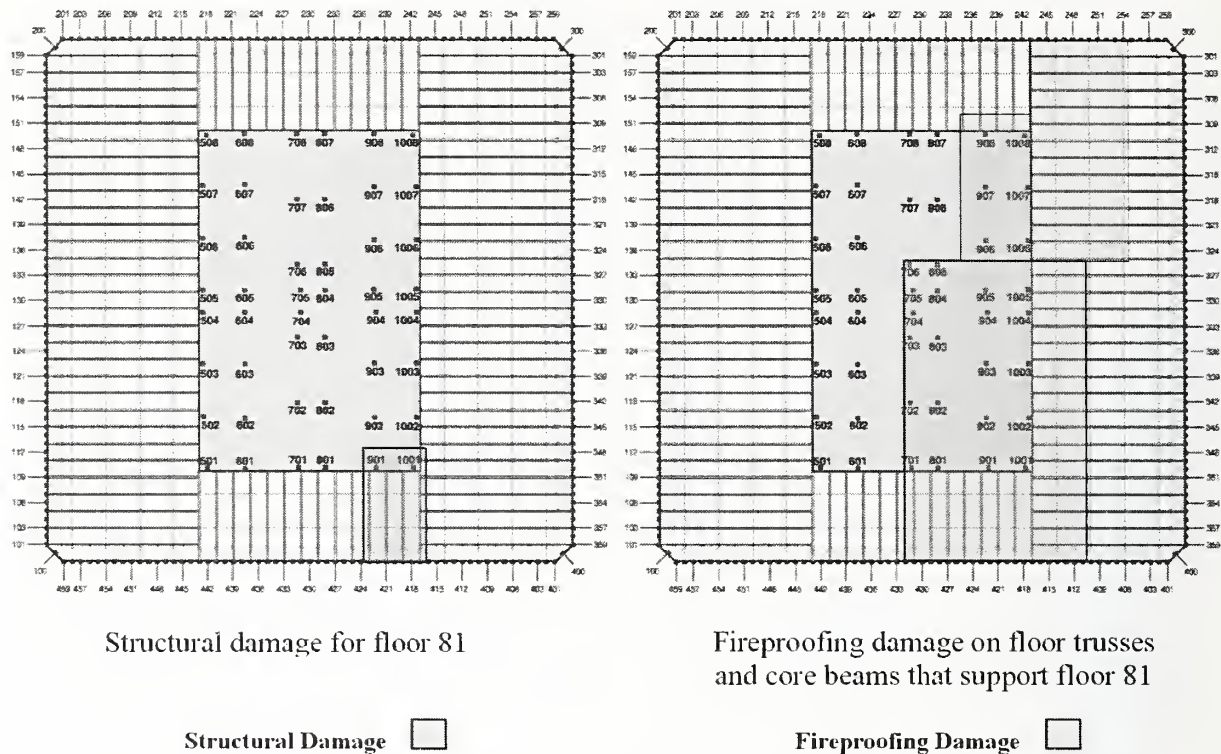
**Figure 6–62. Structural and insulation damage on floor 81 of WTC 2, Case C.**

Some heating of the trusses in the northwest corner was observed at 50 min to 60 min after impact. Although there was no insulation damage to the trusses in this region, the truss elements were covered with 0.6 in. of insulation, which allowed gradual heating in the region where there was fire activity. Fire simulations indicated less activity in the northeast corner on floor 80 compared to floors 81 and 82.

The perimeter columns above floor 81 showed significant heating due to lack of the insulation and intense fire activity in this area. This heating was observed over the entire east face and northeast corner. These perimeter columns reached temperatures above 600 °C at 30 min after impact. The rest of the perimeter columns stayed relatively cool. Core column heating was observed for the 1000 series columns above floor 81 due to a combination of insulation damage and fire activity in this area.
