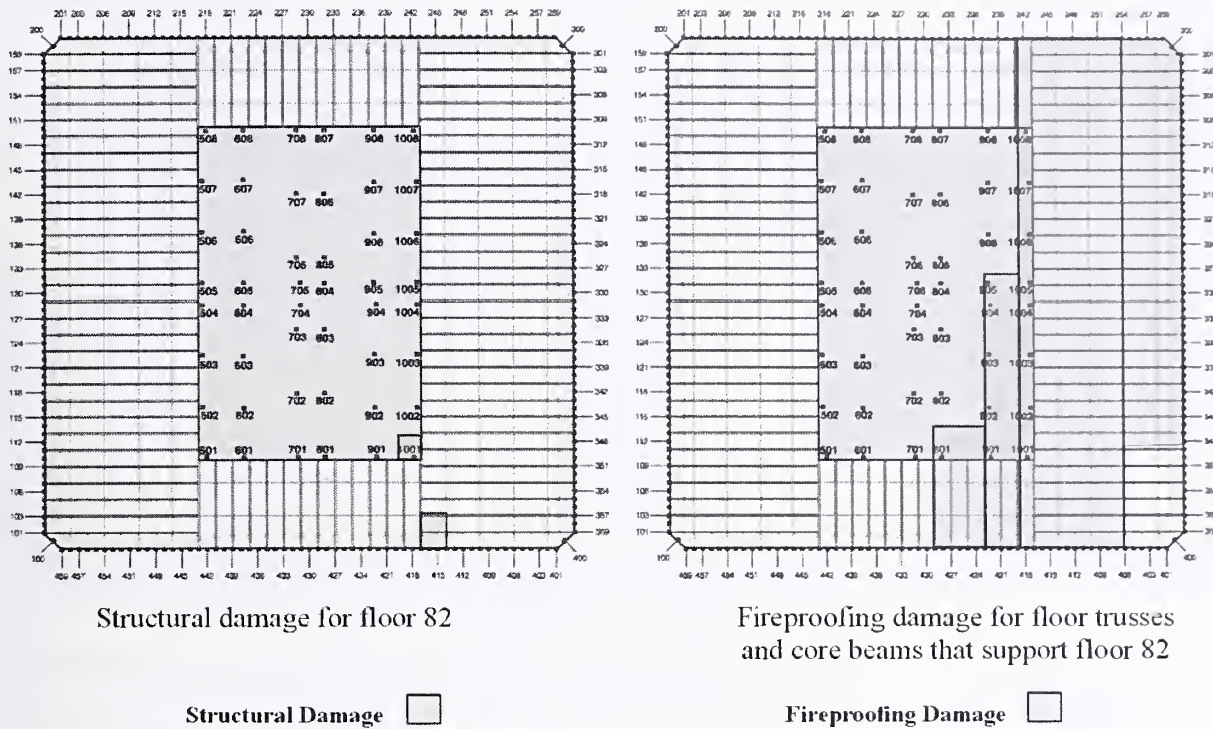
**Figure 6-63. Structural and insulation damage on floor 82 of WTC 2, Case C.**

The extensive insulation damage to the floor trusses and core beams on the east face of the tower resulted in significant heating of the trusses to over 675 °C for the entire duration of the simulation. Some heating was also observed in the southwest corner at 60 min after impact, due to the thinness of the insulation. The perimeter columns above floor 82 showed high temperatures at 40 min to 60 min after impact on the east face, and the core columns on the east side of the core also indicated thermal heating. The west side of the core stayed relatively cool, and there was very little activity in the northwest corner.
