### Damage to the Southwest Corner

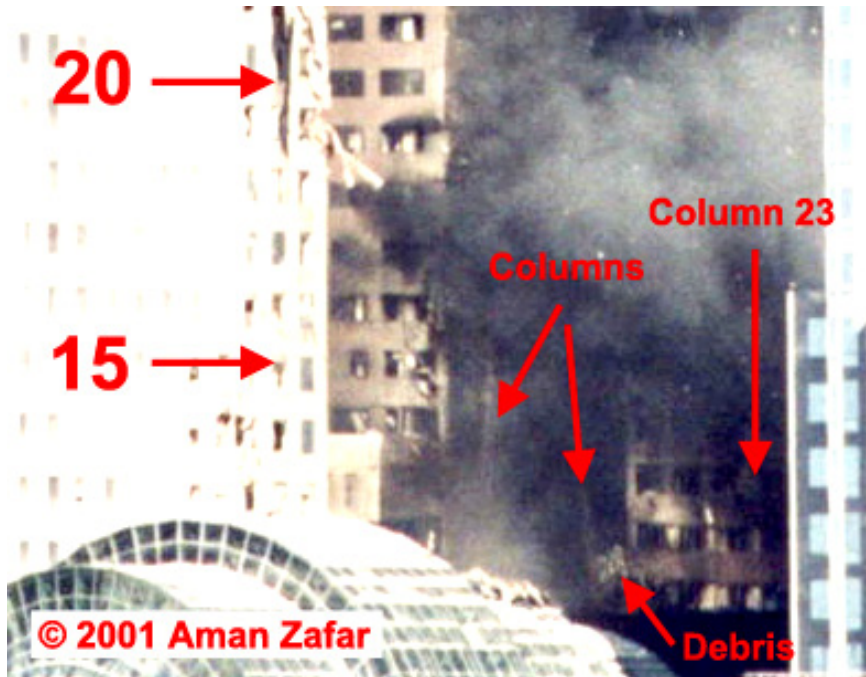
**Figure 5-63.** Enlargement of the lower part of the southwest corner of WTC 7 from Figure 5-62, with certain features identified. The intensity levels have been adjusted.

In Figure 5-49, the area to the immediate right of Column 20 on the 11<sup>th</sup> and 12<sup>th</sup> floors appeared dark, as if it was an opening, while the higher floors were hidden by smoke. However, it is clear from Figure 5-63 that the columns between Column 20 and Column 23 were intact on the 11<sup>th</sup> through 14<sup>th</sup> floors, along with the spandrel beams and at least part of the granite cladding on the 12<sup>th</sup> through 14<sup>th</sup> floors. In Figure 5-49, the granite cladding appears to be damaged below the 13<sup>th</sup> floor near Column 23.

In Figure 5-63, the area between corner Column 15 and Column 20 appears to be open over the 11<sup>th</sup> floor to the 15<sup>th</sup> floor. Closer inspection reveals what appear to be two columns (marked with arrows) in the opening. They are located near the positions expected for Columns 16 and 19. These columns are not parallel to the building edge or Columns 20 to 23. The top of the visible section of Column 19 is bent inward toward the west, and the bottom of Column 16 is bent in the same direction. In Figure 5-49, there is a straight edge visible near the expected location for Column 19 on Floors 9 and 10 that appears to have been pushed towards Column 20. There are no signs of Columns 17 or 18 in Figure 5-63.

Evidence shows that there was extensive structural damage to the southwest corner of the building, and in particular the corner Column 15, from the 17<sup>th</sup> floor down to the 7<sup>th</sup> floor. The indications of damage on the southwest corner of WTC 7 in Figure 5-63 are more clearly seen in the following figures.
