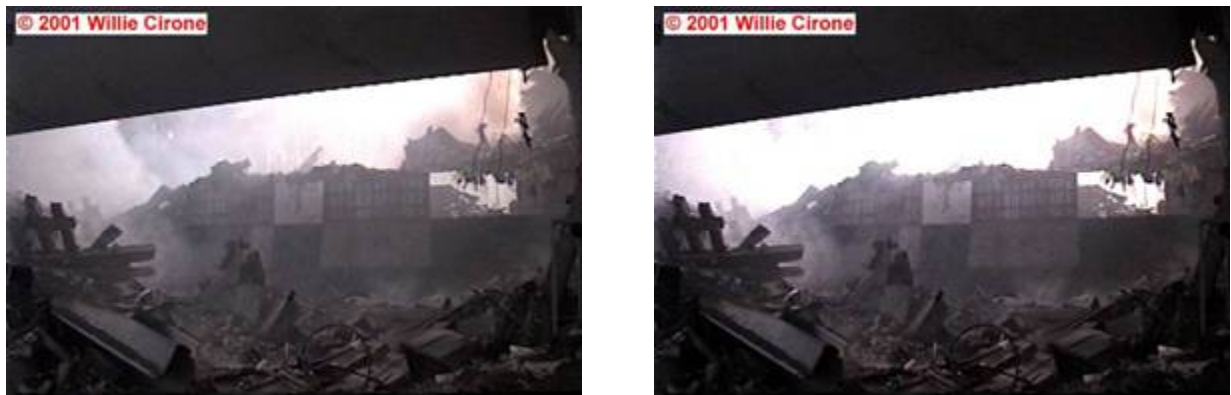
**Figure 5–72. Two versions of a frame from a video taken from the corner of Vesey Street and West Broadway in the early afternoon.**

A second view of Vesey Street and the Promenade taken from a short video clip is shown in Figure 5–72. The dark area at the top of the image is the bottom of the Pedestrian Bridge. In the unaltered left view, large amounts of smoke are visible on the far side of the Promenade. In the right view, the intensity levels have been adjusted to emphasize the darker areas in the image. A number of steel panel sections are visible on the left side of the street between the Pedestrian Bridge and the Promenade. It is also possible to see that several panel sections landed on or near the south end of the Promenade, and this end may be partially collapsed. The portion of a panel section near the center of the street is visible, but is not as easily identified as in Figure 5–70. A part of the large piece of debris observed earlier leaning up against the south face of WTC 7 is visible at the far right of the image. The size and shape of the object suggest that it was a steel column or beam. In all, the main portion of the east side of the Promenade, with the possible exception of the far south end, was not collapsed by the steel from WTC 1, although the raised side structures had suffered considerable damage.

Left: the frame as captured; Right: the image with intensities adjusted to emphasize the darker areas.
