### 5.6.3 Visual Observations of Fire Growth and Spread in WTC 7

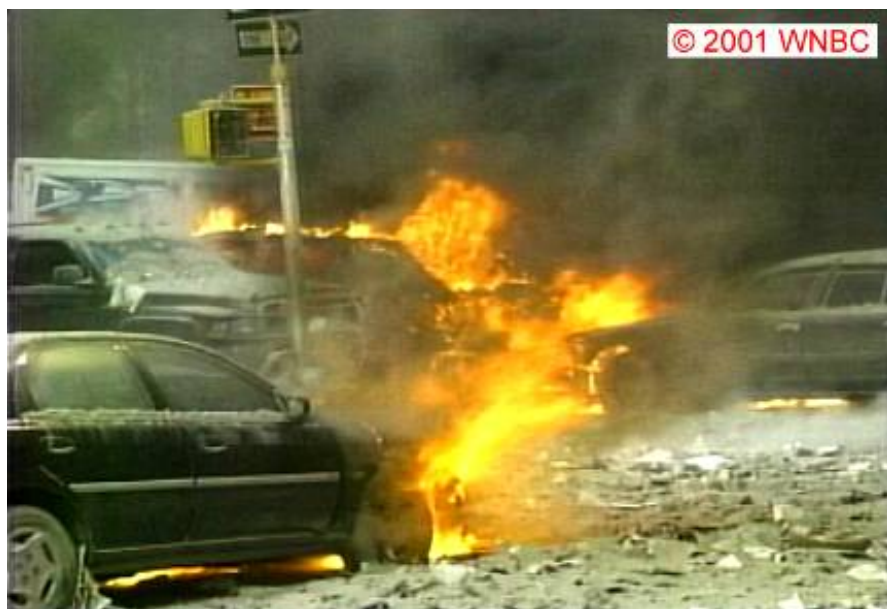
**Figure 5–108. Frame taken from a video clip filmed near the corner of West Broadway and Barclay Street showing flames burning on a number of vehicles.**

The time could not be accurately determined. The intensity levels have been adjusted.

The number and wide distribution of vehicle and building fires ignited following the collapses of WTC 1 and WTC 2 confirm that substantial numbers of burning sources capable of igniting fires reached the ground and were widely distributed by the dust- and debris-laden air flows. Since fires were observed on the ground surrounding WTC 7, it is possible that potential ignition sources entered WTC 7 through openings created in the south and west faces of the building during the collapses of the towers. NIST found no evidence to confirm this possibility, but the available data suggest that this was highly likely.
