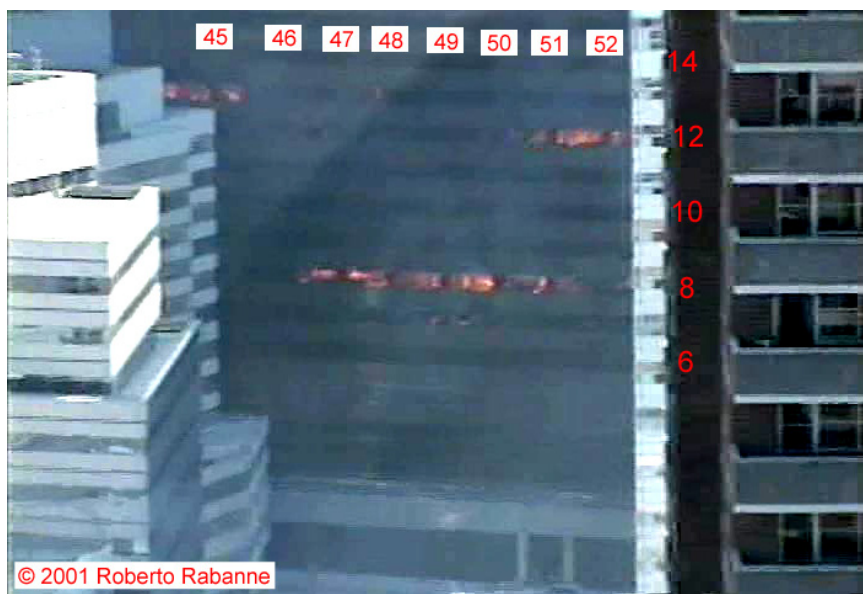
Even though 123 Barclay Street was a full block north of the south face of WTC 7 and was nearly completely shielded from the WTC site by WTC 7 and the Verizon Building (see Figure 5–2), all of the windows in the main lobby facing Barclay Street were broken, and the lobby was covered by a thick layer of dust. This observation provides another example of the potential of the dust clouds created by the collapses of the towers to break windows and distribute material. There was no indication that fires ignited in the lobby. Initial views of WTC 7 shot by this news crew were taken through the broken windows in the lobby. Figure 5–132 shows a view of the northwest corner of WTC 7 taken from a video clip shot through the open windows. The time assigned for this video clip is estimated relative to that for Figure 5–134 provided below. Figure 5–132 reveals a great deal about the recent fire behavior. Consider the west face. Flames are visible coming from window 8-6 on the 8<sup>th</sup> floor, and heavy smoke is flowing from multiple windows starting at the northwest corner and extending at least as far south as window 8-8. Several video clips were shot from near the same location as Figure 5–132. A frame from one of the clips recorded slightly earlier showing a much closer view of the west face is reproduced in Figure 5–133. In this image, flames are visible in windows 8-3 to 8-5, with heavy flames coming from window 8-3. In a longer distance view from the same clip, flames can also be seen coming from windows 8-1A, 8-1B, and 8-2.

Taken together, these video clips indicate that an intense fire spanning at least half the west side of the 8<sup>th</sup> floor was burning at this time. Conversely, even though there was heavy blackening of the façade above open windows 7-1A, 7-1B, 7-3, and 7-4 visible in the clips, indicating the earlier presence of a fire, no

**Figure 5–131.** This frame from a video shot from a building to the northwest of WTC 7 was taken around 3:50:13 p.m. with an uncertainty of  $\pm 3$  min. The intensities have been adjusted and column and floor numbers added.
