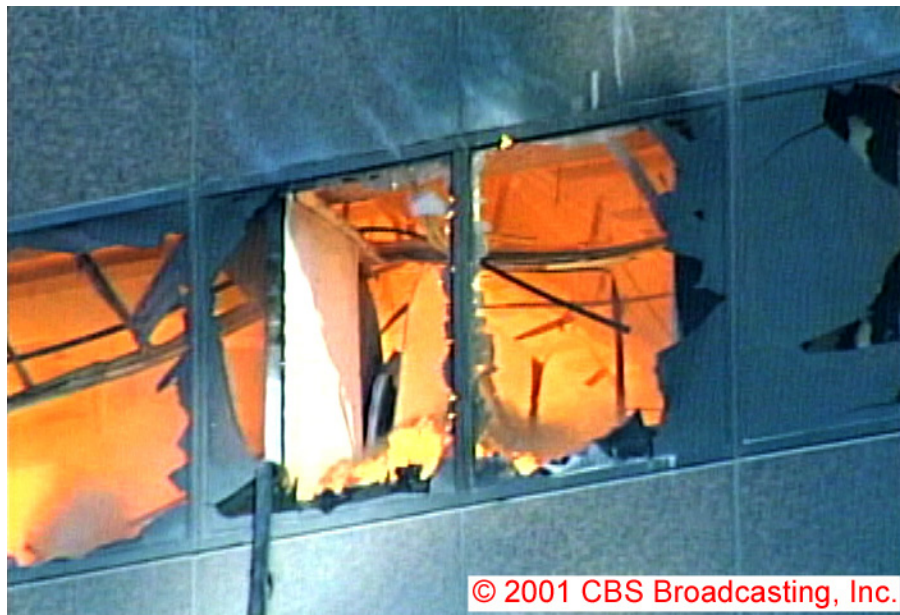
burning on the window frames. In the video clip, it is clear that the internal smoke is flowing away from the open windows. This is the strongest evidence identified that the effluent created by fires burning near the north face of WTC 7 often vented elsewhere from the building, most likely due to pressure differences created by the ambient wind.

**Figure 5–138. Frame taken from a video shot from near the corner of Greenwich Street and Park Place showing windows 8-47B to 8-48A between 3:49 p.m. and 3:54 p.m.**  
The intensities have been adjusted.

Additional details concerning the local effects of the fires can be seen in Figure 5–138. For instance, the distorted frame that had held the drop ceiling for the area is still in place above the windows. The ceiling tiles have been dislodged. Further inside, it is possible to see the floor slab for the 9<sup>th</sup> floor. There appears to be a wall partition visible through window 8-47C. It seems to terminate at the drop ceiling. For this reason, it would have been unlikely to have been an effective fire barrier.
