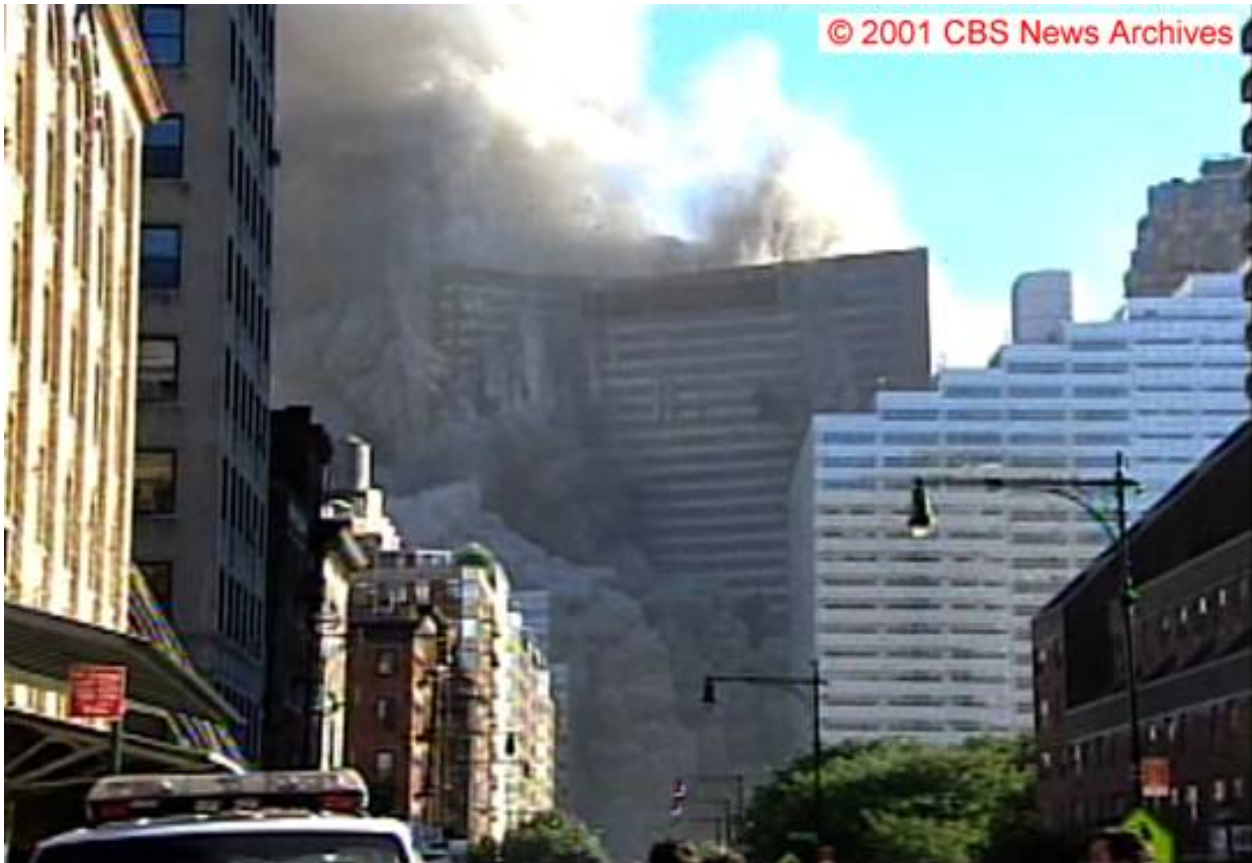
Figure 5–212 and Figure 5–213 show frames from the northeast (Camera 6) and Greenwich Street (Camera 9) video clips for the same time as the images in Figure 5–211. In both frames, the distortions of the falling building stand out. The kink near Column 47 is prominent in Figure 5–213, while in Figure 5–212, a strong distortion is present near the east edge of the north face. Both frames also show the large amount of dust being pushed out of open windows higher up in the building and the huge dust clouds forming near its base. In Figure 5–212, large amounts of dust have been pushed from near the base of the building on the east, north, and west sides. A prominent feature in Figure 5–213 is the large pulses of dust flowing upward through the roof on the east side and near the center.

**Figure 5–213.** Frame from the Camera 9 video clip in Figure 5–192 shows the north face of WTC 7  $11.0 \text{ s} \pm 0.2 \text{ s}$  after the east penthouse began to move downward.

The intensities have been adjusted.
