### East-west Motion of the Building as the East Penthouse Collapsed

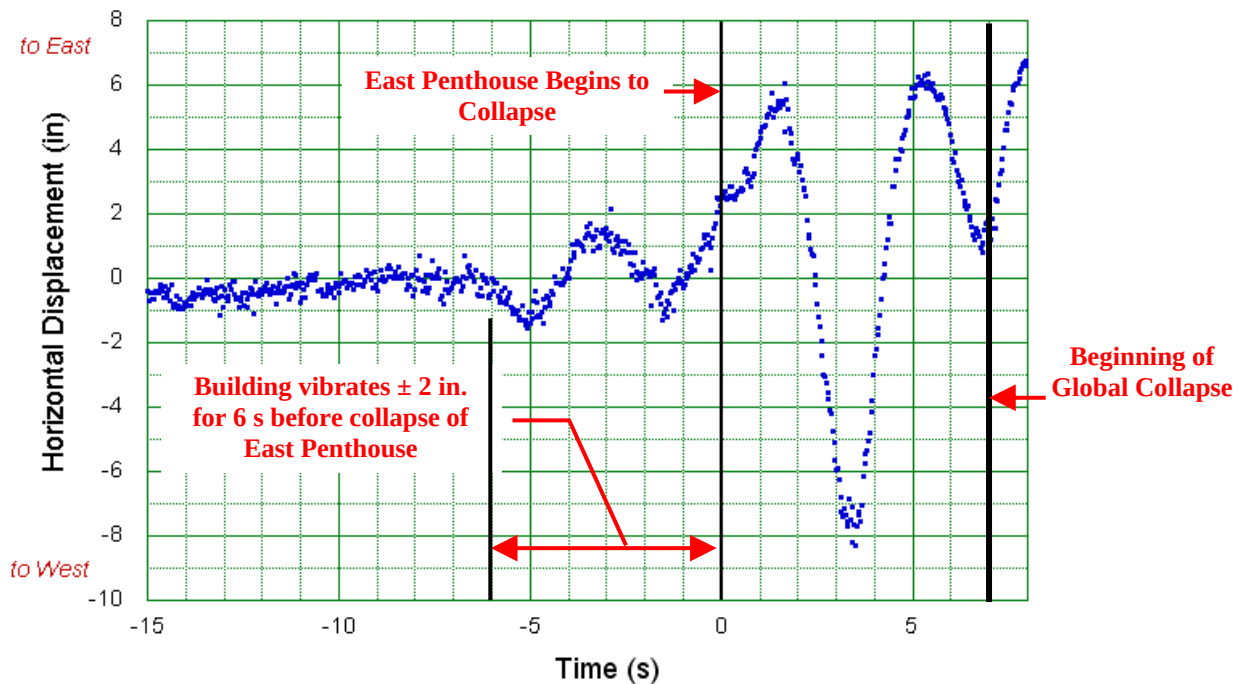
**Figure 8–8. Horizontal motion detected on the northwest edge of the building.**

As evidenced by the breaking glass in the upper stories (Figure 8–2 and Figure 8–4), collapse on the east side of the building was not limited to the roof and penthouse. Failures were likely occurring on many floors below with sufficient energy to cause the 47 story building to move laterally in its strong (east-west) direction (Figure 8–3). An analysis of one of the videos using frame subtraction to highlight differences between two video frames (Appendix C), revealed that the northwest edge of the building showed horizontal motion of around 15 in. peak-to-peak oscillation as the east penthouse collapsed (Figure 8–8). Measurable, though smaller, vibrations (about  $\pm 2$  in.) were detected at least 6 s before the east penthouse began to collapse. This suggested that a major disturbance occurred within the building prior to visible evidence of collapse (movement of the east penthouse) from available video recordings.
