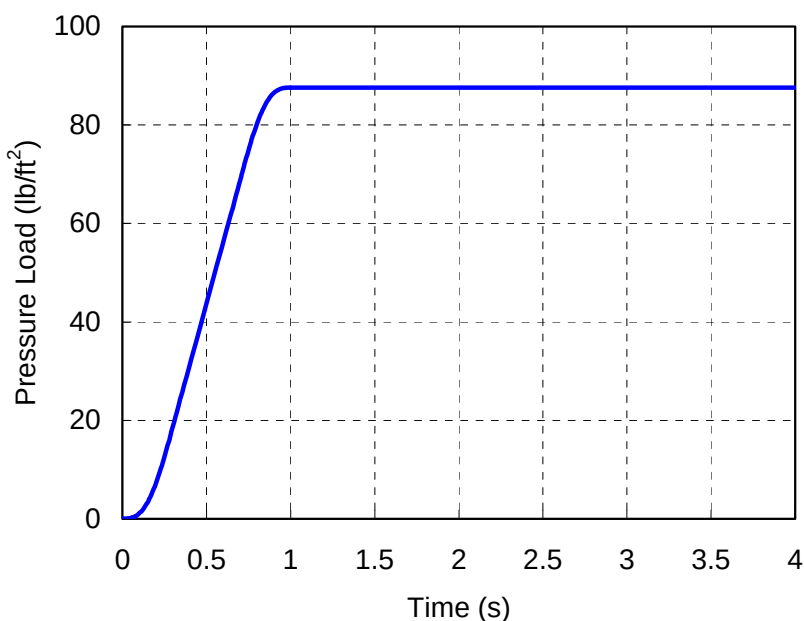
**Figure 8–24. Time history of gravity loading, applied as a downward pressure on the concrete slab and metal deck.**
