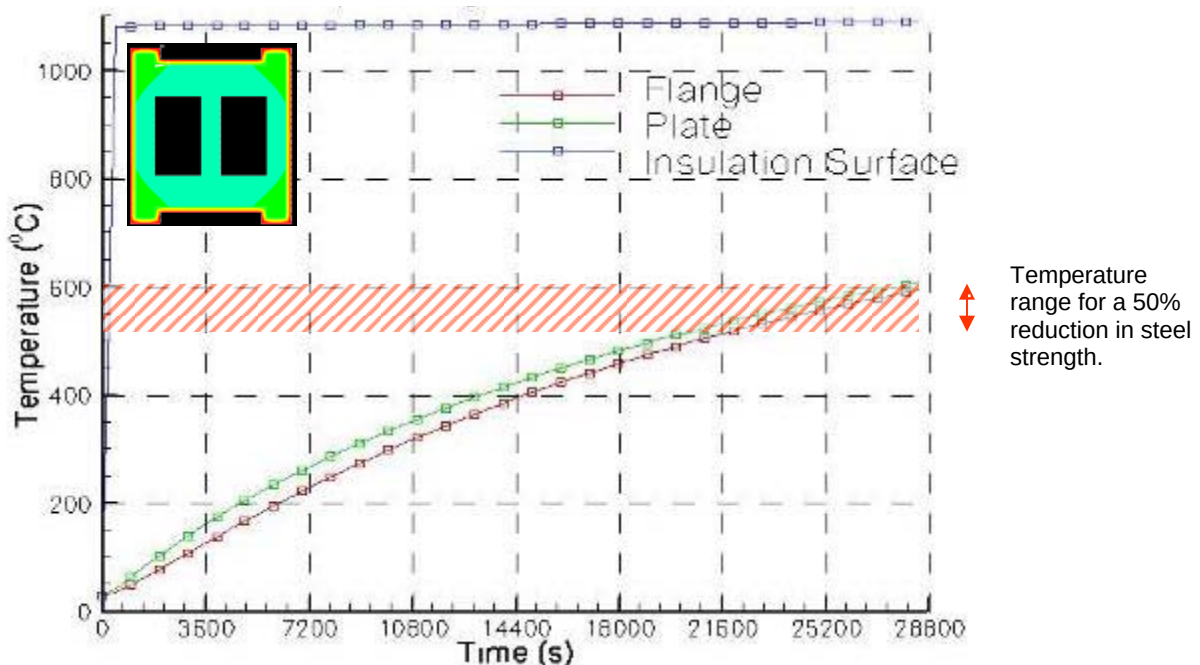
Chapter 8 suggests that the initial effect of a fire weakening the building structure would have occurred on the east side of the building. The interior columns that might have been affected were Columns 79, 80, and/or 81. Figure 9–3 shows the developing thermal conditions for these heavy columns, insulated with 9/16 in. of thermal insulation<sup>3</sup>, when exposed to a uniform temperature of 1100 °C. It would have required a continuous, fully developed fire at the location of a column for approximately 7 h for a 50 percent reduction in its strength to occur (Section 4.1.2, NIST NCSTAR 1-6).

**Figure 9–3. Minimum heating of reinforced heavy columns to initiate global collapse.**  
The column modeled is a W14x730 with 9/16 in. of thermal insulation.

<sup>3</sup> The nominal column insulation thickness for columns larger than a W14x228 was nominally 7/8 in. (Chapter 2). As part of determining the rate of heating in Column 79, a reduced thickness was evaluated.
