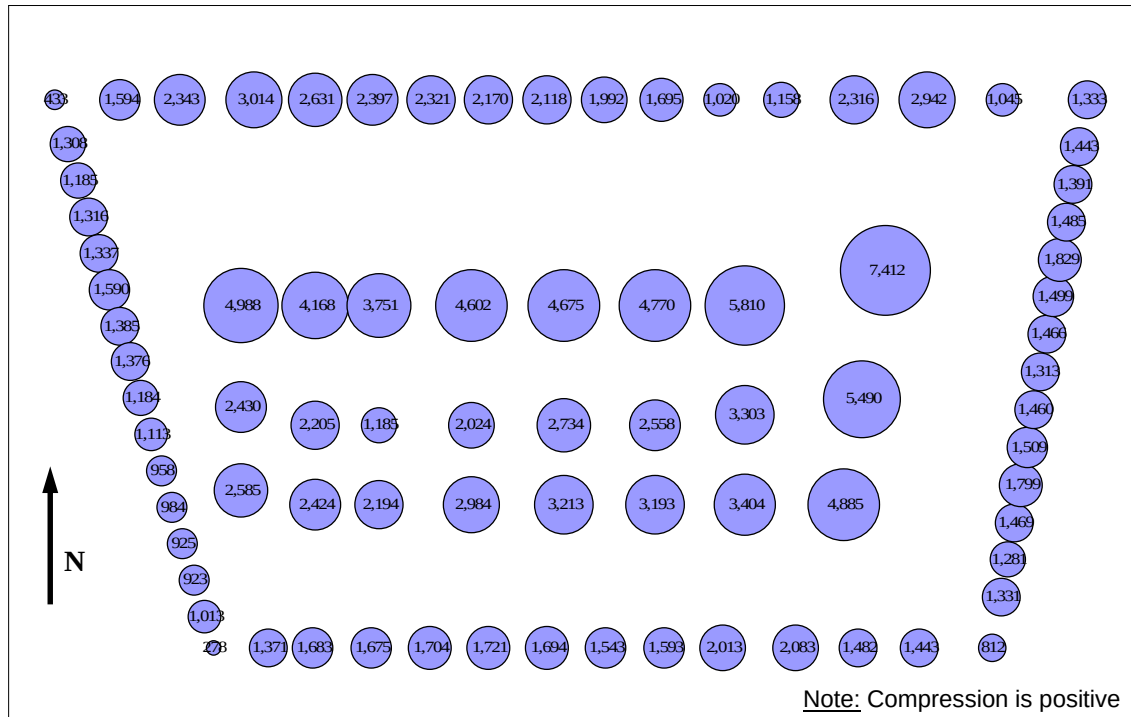
Summation of Column forces:

| North: 32,500 kip | East: 19,300 kip |
| South: 21,100 kip | West: 16,600 kip |
| Interior: 87,000 kip | Total: 176,500 kip |

**Figure 11–29. Column forces (in kip) above Floor 8 at 3.5 h for Case B temperatures.**
