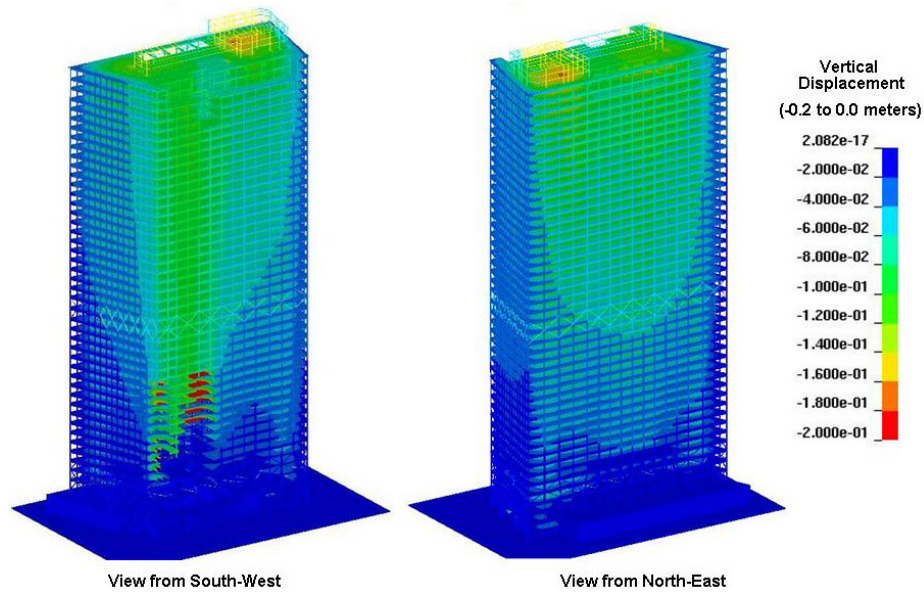
Figure 12-39. Calculated vertical displacements after impact damage.

debris impact damage application. The figure shows a downward displacement of up to 8 in. (about 1/900 of the total building height) on the south face toward Zone 1 damage due to column removal. The analysis shows that the building remained stable and that columns and floors above the damaged zone were able to redistribute the loads through Vierendeel truss action.

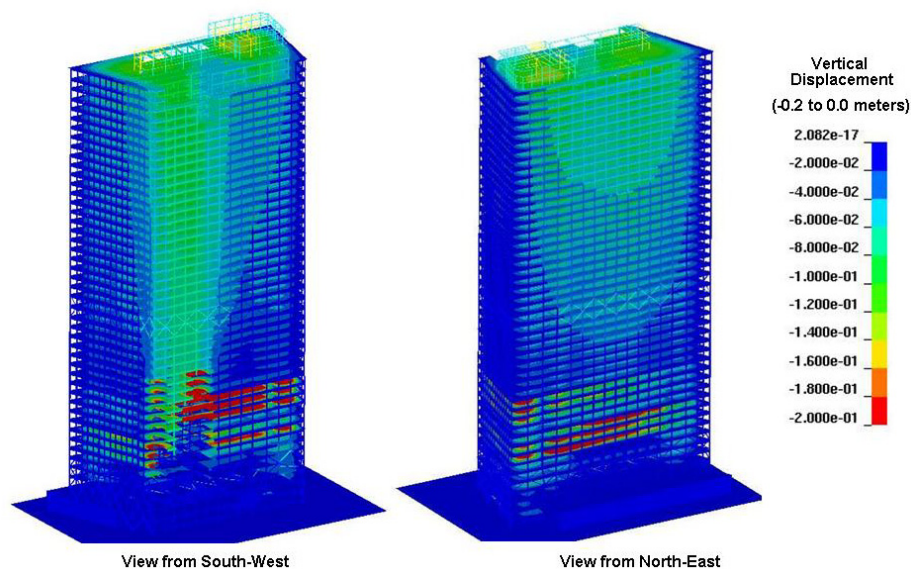
Figure 12-40. Calculated vertical displacements after temperature initialization.

Figure 12-40 shows the subsequent change in vertical displacement after Case B, 4.0 hour temperatures were applied. Detail views illustrating the vertical displacements of the lower floors, up to Floor 14, are shown in Figure 12-41 (a) after debris impact damage application and Figure 12-41(b) after full
