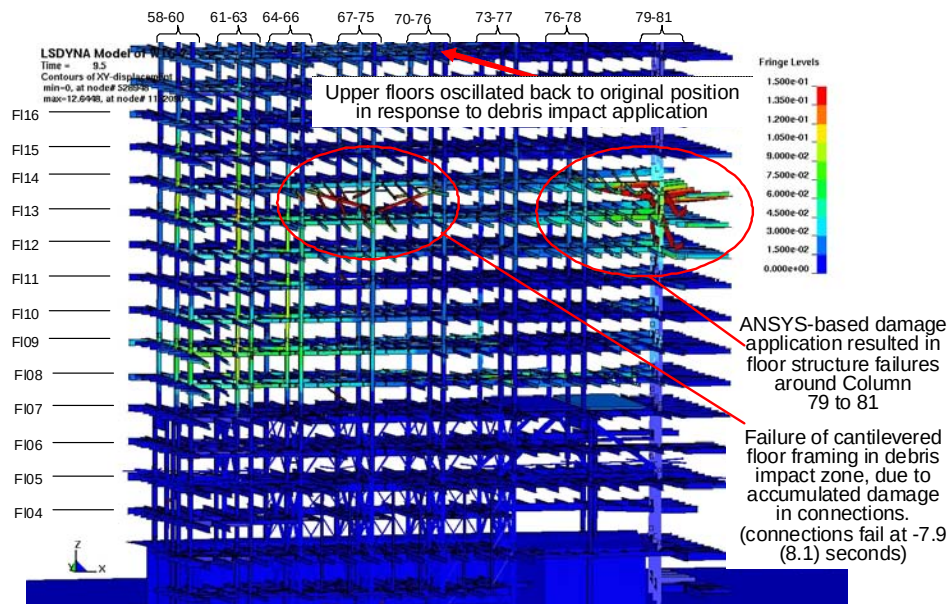
**Figure 12–42. The collapse of Floors 13 and 14 in the northeast region [Time: -6.5 (9.5) s]**
