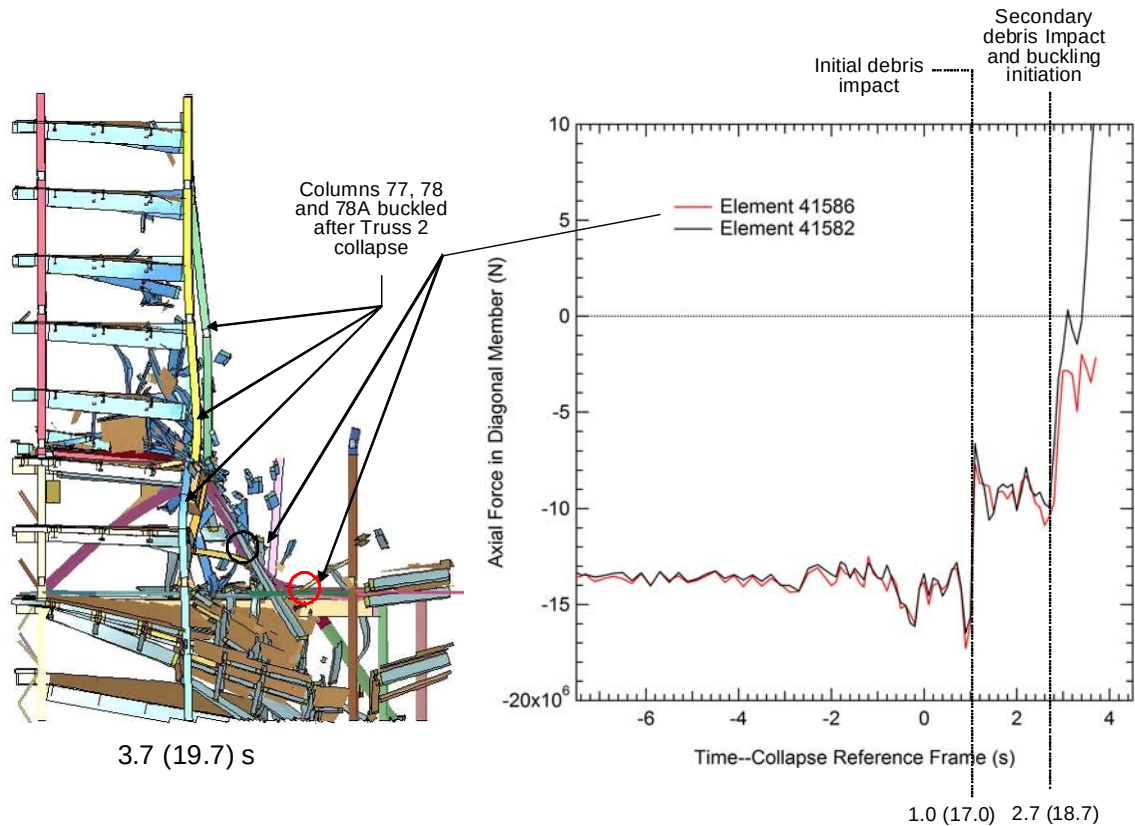
**Figure 12–51. Truss 2 collapse. View from south (most of debris removed from view).**
