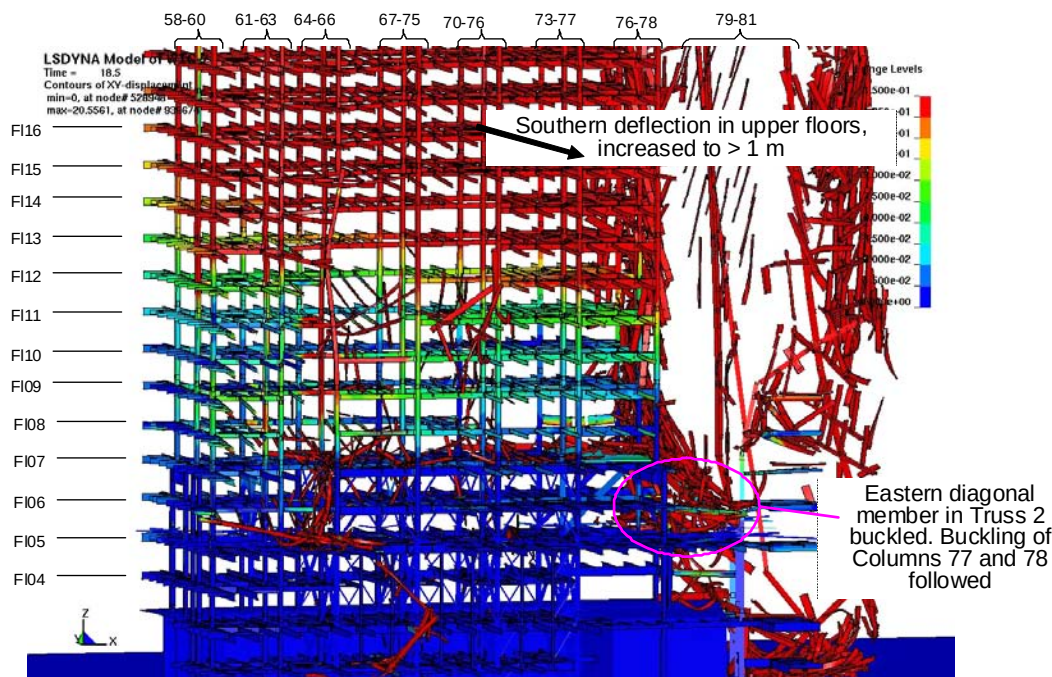
The westward progression of column failures also indicated that the failure of Truss 2 was not essential to the failure of Columns 77 and 78, as they would have buckled similar to the other interior columns.

Figure 12-52. Failure of Columns 77 and 78 due to failure of Truss 2 from debris impact [Time: 2.5 (18.5) s].

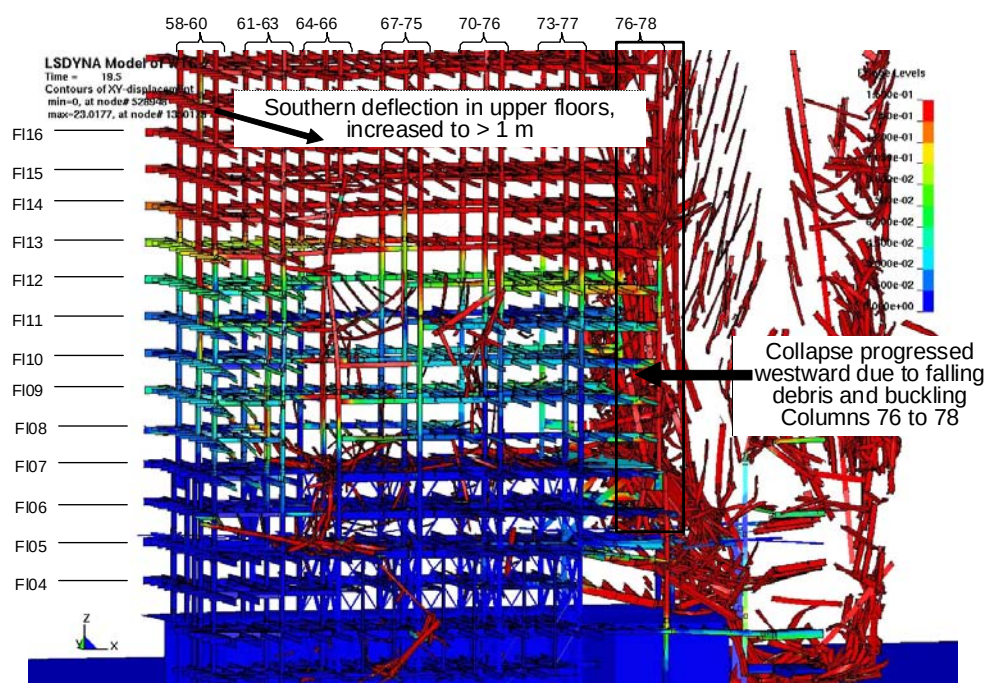
Figure 12-53. Buckling of Column 76 from the load transfer and debris impact from the buckling of Columns 79 and 77 [Time: 3.5 (19.5) s].
