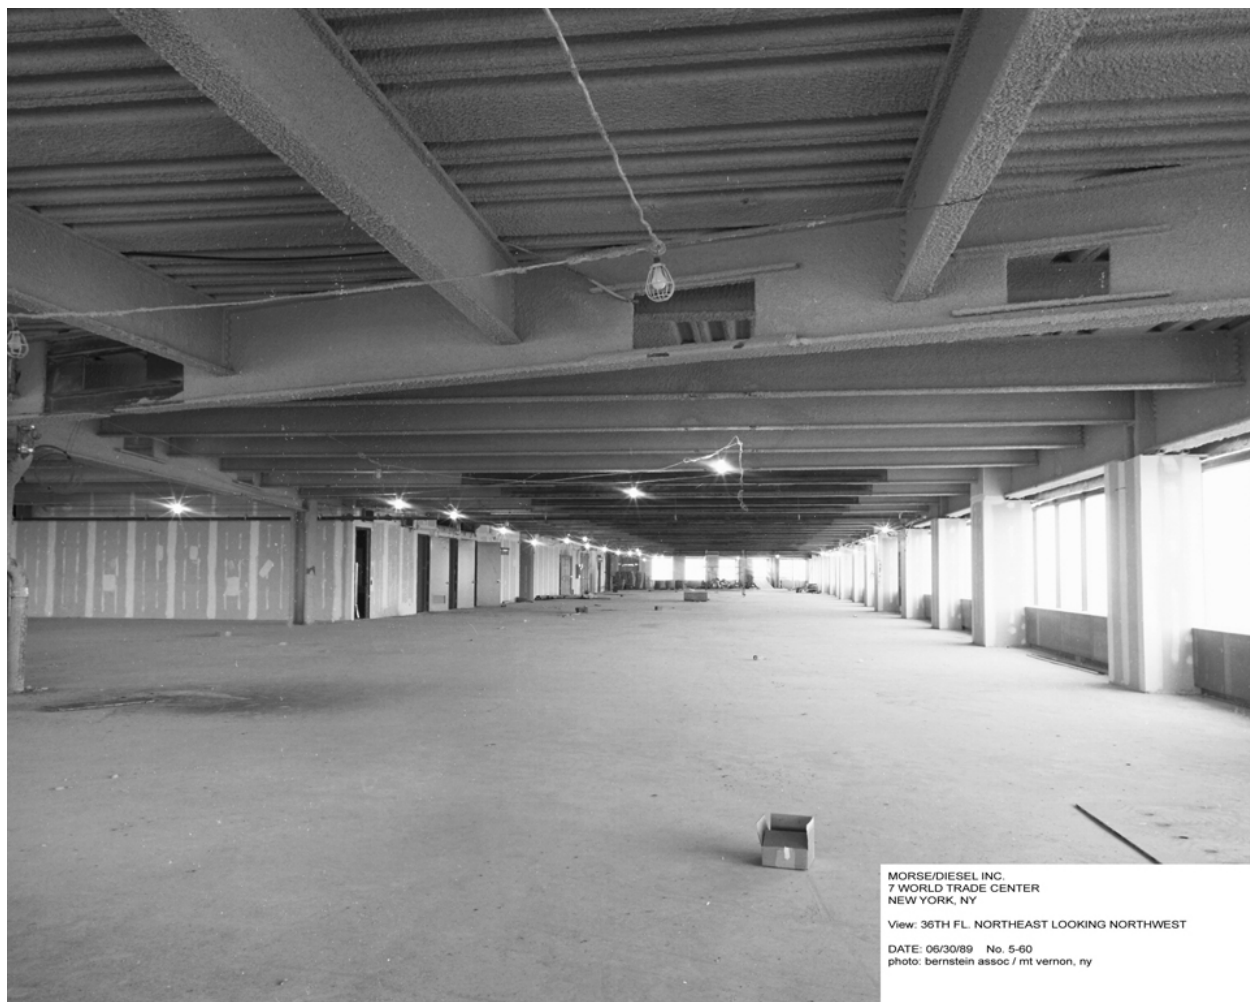
**Figure 2–29. Photograph of Floor 36 during renovations, showing SFRM on steel beams and metal deck, looking dated 06/30/89.**
