### 6.8.2 Subassembly Impact Analyses

### 6.8.3 Aircraft Impact Conditions

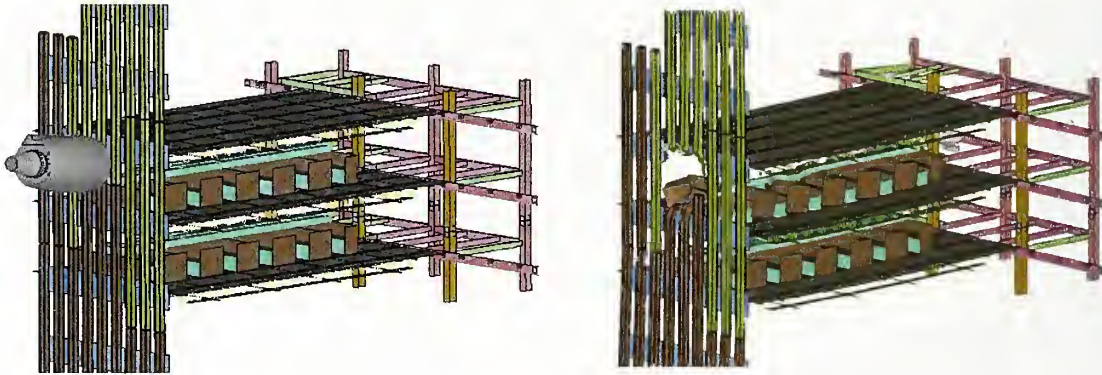
**Figure 6–17. Response of a tower subassembly model to engine impact.**

- The mass of the concrete floor slab and nonstructural contents had a greater effect on the engine deceleration and subsequent damage than did the concrete strength.
- Variation of the failure criteria of the welds in the exterior columns did not result in any noticeable difference in the damage pattern or the energy absorbed by the exterior panels.
