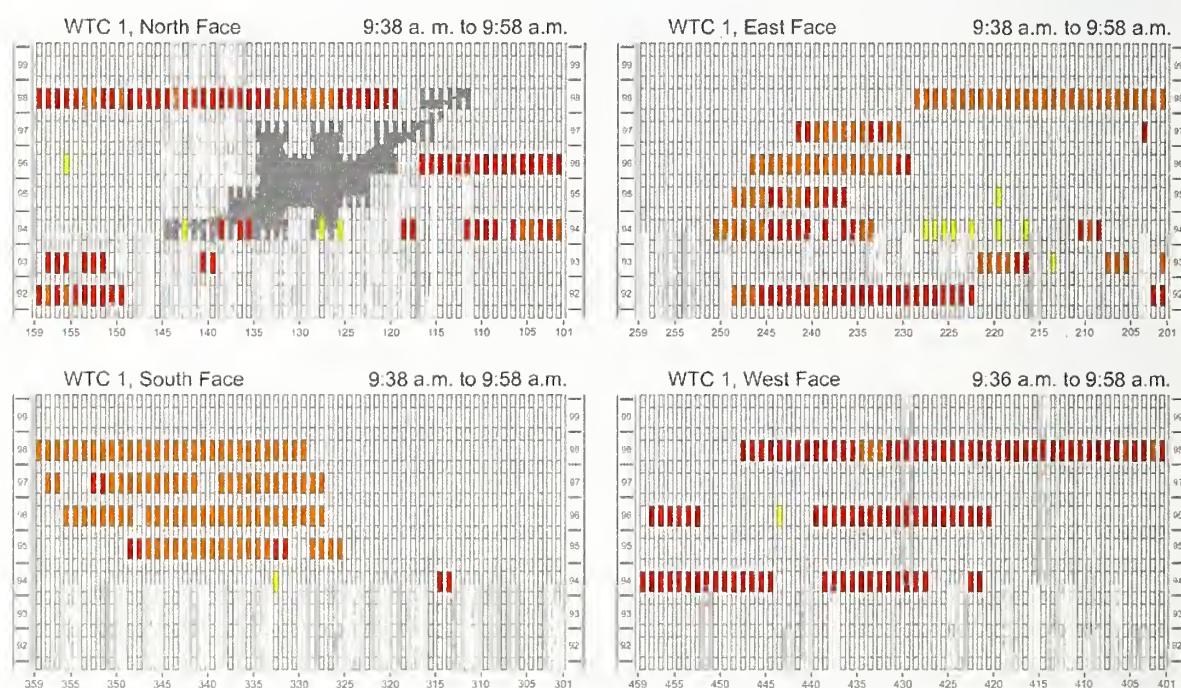
Seventy-five minutes after the impact, approaching 10:00 a.m., the fire on the 97<sup>th</sup> floor had begun to burn itself out, but the fire on the 94<sup>th</sup> floor had intensified and filled much of the north half of the floor (Figure 2–7). Starting about 9:30 a.m., there were vigorous fires on nearly the full perimeter of the 98<sup>th</sup> floor. There was still almost no burning on the 99<sup>th</sup> floor or above.

**Figure 2–7. Representation of exterior views of the fires on the four faces of WTC 1 from about 9:38 a.m. to 9:58 a.m.**
