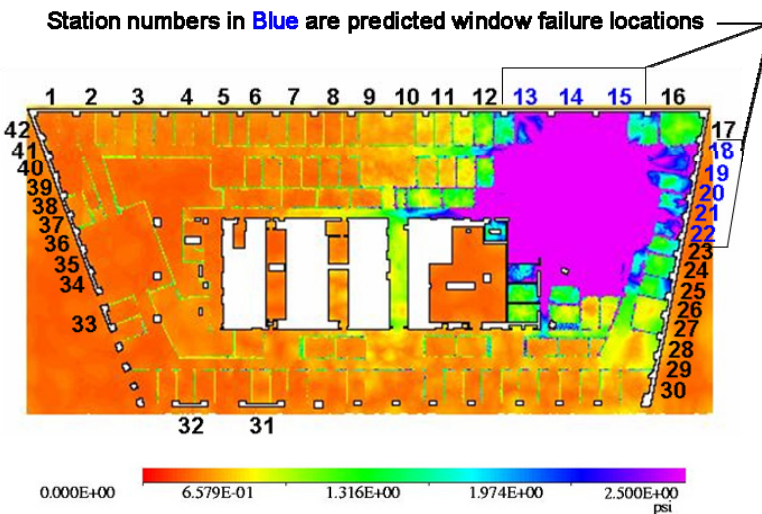
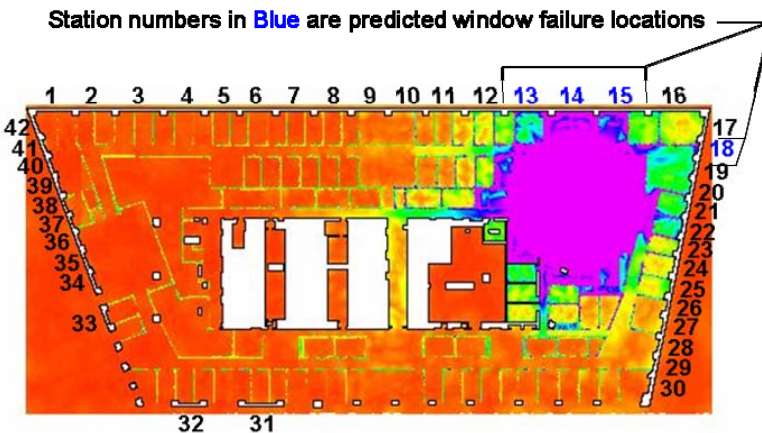
**Figure 3–1. Peak overpressure and broken window locations.**

Figure 3–1 shows the results for the two shaped charges applied to Column 79 on a tenant floor that was highly partitioned, such as Floor 12. Nearly all the windows on the northeast section of the floor subjected to a blast would have been broken, even by the smaller charge. Simulations for a floor that was not highly partitioned led to more extensive window breakage.

Top: 9 lb shaped charge; bottom: 2 lb charge.

The actual window breakage pattern on the visible floors on September 11, 2001 (NIST NCSTAR 1-9, Chapter 5) was not at all like that expected from a blast that was even 20 percent of that needed to damage a critical column in WTC 7. The visual evidence did not show such a breakage pattern on any floor of WTC 7 as late as about 4:00 p.m. or above the 25<sup>th</sup> floor at the time of the building collapse initiation. Views of the northeast corner of WTC 7 at the time of the collapse were obstructed by other buildings.
