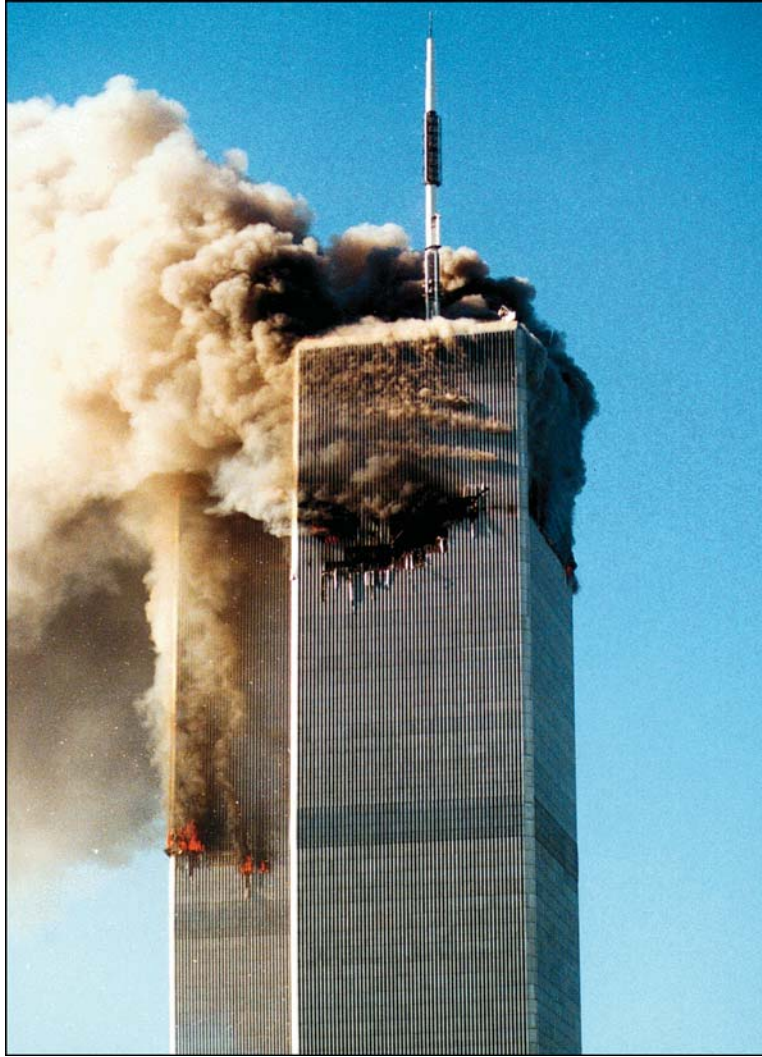
*Figure 2-30**North face of WTC 2 opposite the zone of impact on the south face, behind WTC 1.*
