### 3.4 Observations

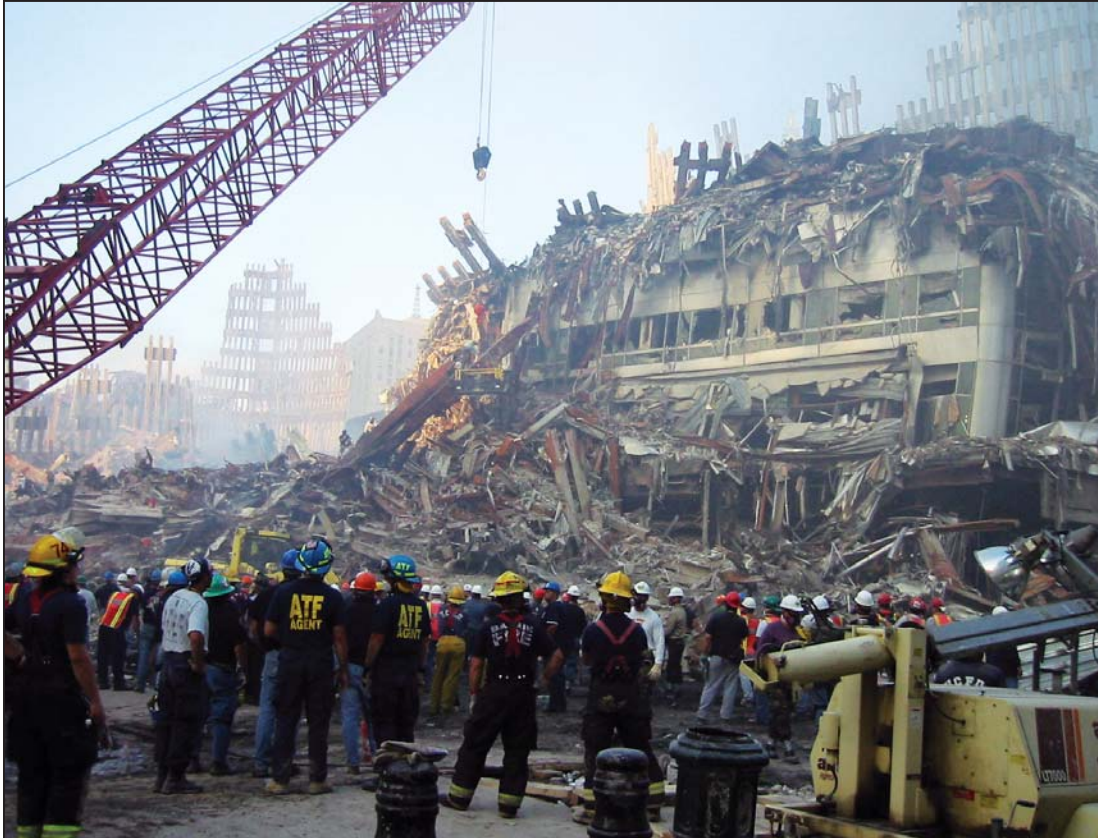
Figure 3-8 Remains of WTC 3 after collapse of WTC 1 and WTC 2.

WTC 3 was subjected to extraordinary loading from the impact and weight of debris from the two adjacent 110-story towers. It is noteworthy that the building resisted both horizontal and vertical progressive collapse when subjected to debris from WTC 2. The overloaded portions were able to break away from the rest of the structure without pulling it down, and the remaining structural system was able to remain stable and support the debris load. The structure was even capable of protecting occupants on lower floors after the collapse of WTC 1.
