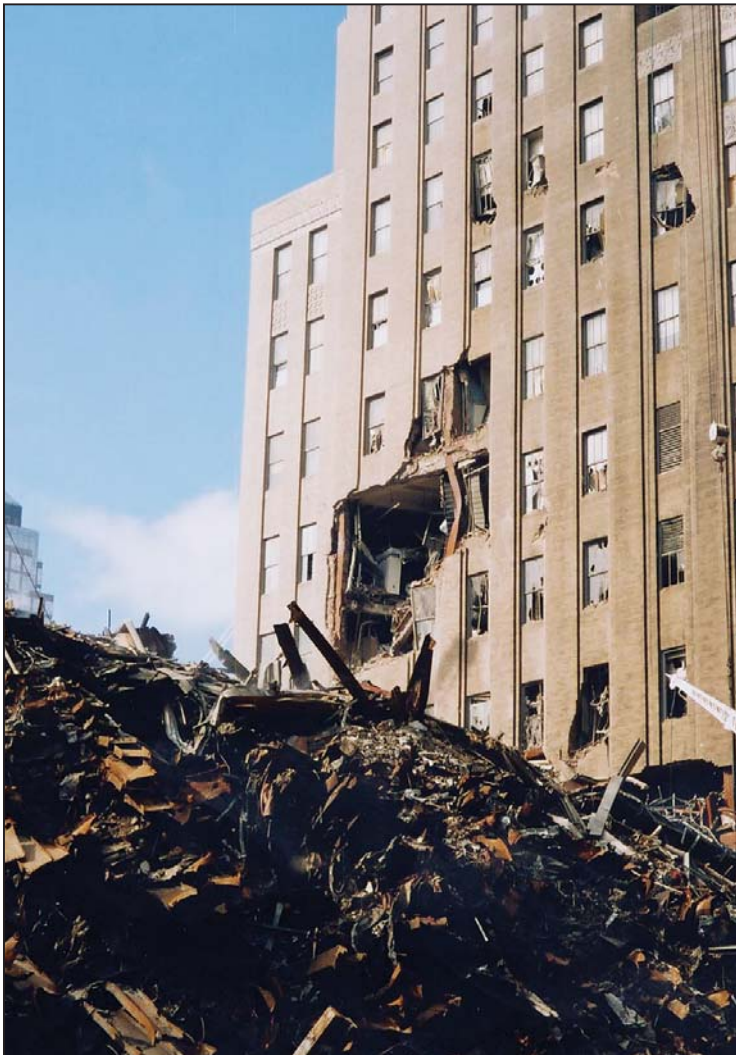
The east (Washington Street) side of the building was damaged from about the 9th floor down, primarily due to the impact of debris sliding out from the base of WTC 7 (Figures 7-6, 7-7, and 7-8). Some damage may have also been caused by WTC 1 debris. In addition to fairly extensive façade damage (bricks and windows), there was damage to two bays of slab and framing at the 1st, 4th, and 7th floors and to one

*Figure 7-6*  
*Verizon building – damage to east elevation*  
*(Washington Street).*
