## 5.4 VISUAL IMAGERY AVAILABILITY FOR WTC 7 DAMAGE AND FIRE CHARACTERIZATION

### 5.4.1 Overview

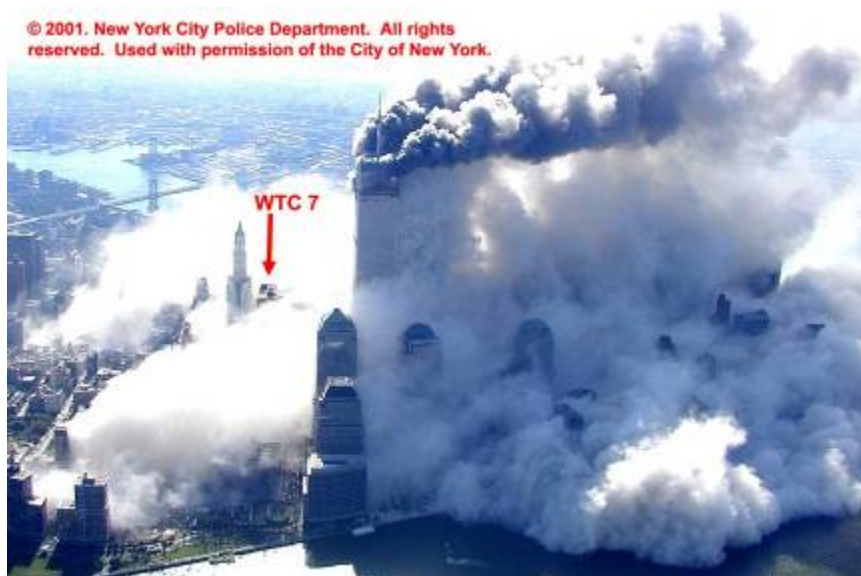
**Figure 5–27. Cropped photograph showing the dust cloud created by the collapse of WTC 2.**

The image was shot from the west at 10:03:56 a.m. WTC 7 can barely be seen above the cloud. The intensity levels of the photograph have been adjusted.

When WTC 2 collapsed at 9:58:59 a.m., the situation around the WTC complex completely changed. The collapse generated a huge dust cloud that, due to its high density, spread much like a liquid around the buildings of Lower Manhattan. An image of this cloud taken nearly four minutes after the collapse is shown in Figure 5–27. In the immediate aftermath it was not possible to see WTC 7. Thousands of people rapidly fled the area. As a result, the amount of collected imagery shot from the vicinity of the WTC site abruptly dropped when WTC 2 collapsed. Due to the prevailing wind, the dust cloud around WTC 7 began to clear by around 10:15 a.m. and some nearby imagery of WTC 7 was recorded during the period between the collapse of WTC 2 and the collapse of WTC 1 at 10:28:22 a.m.
