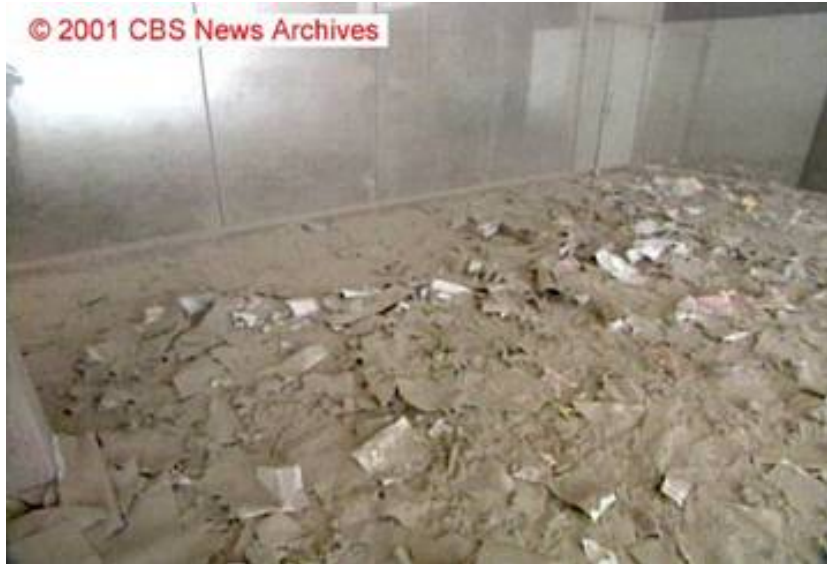
**Figure 5-38. Video frame showing a corner of the main lobby on the 3<sup>rd</sup> floor of the south side of WTC 7, taken around 10:15 a.m. The intensity levels have been enhanced.**
