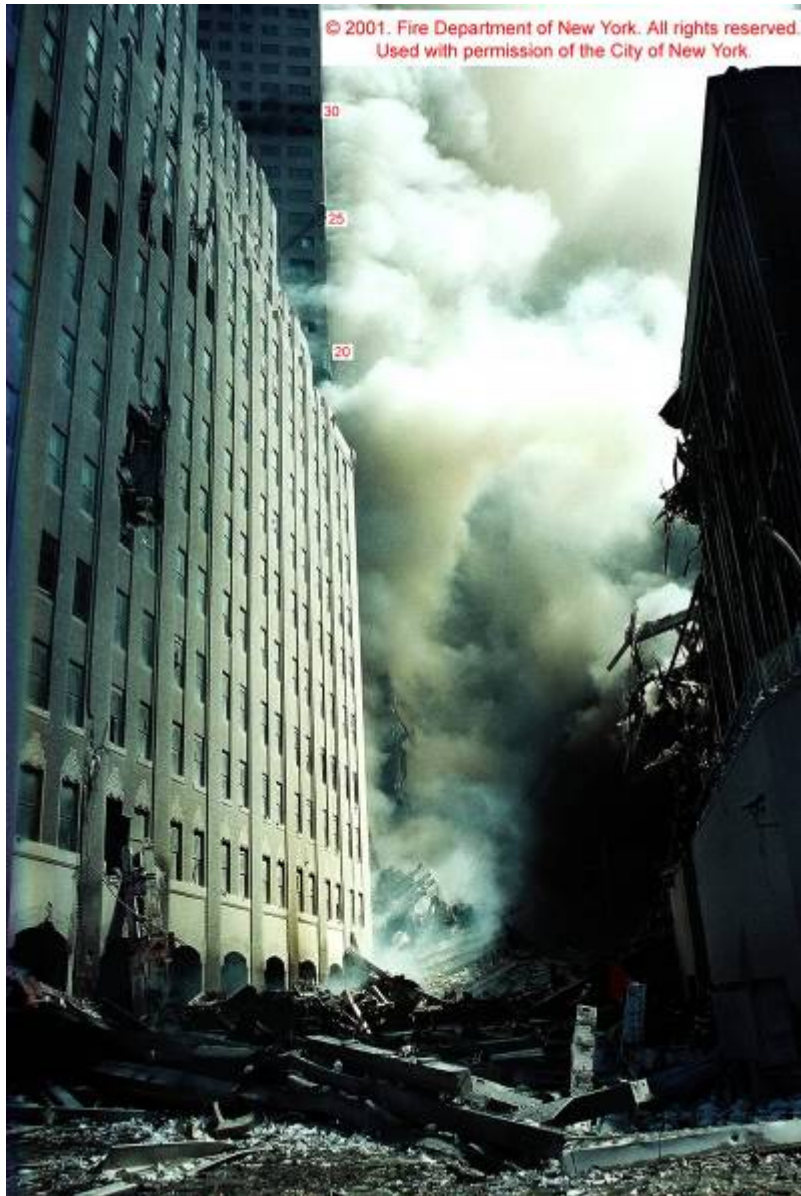
**Figure 5–56. Photograph of damage on the south face of WTC 7, shot looking down Vesey Street between the Verizon Building (left) and WTC 6 (right), shortly after 1:30 p.m.**  
The intensity levels have been adjusted.

The smoke near the base of WTC 7 had momentarily cleared at this time, and it is possible to observe a damaged area on the lower part of the south face. An opening in the building spanning several floors is apparent. This part of the image has been enlarged in Figure 5–57. A row of several windows with some columns visible can be seen near the top of the visible damage. Closer inspection reveals that there is another row of windows immediately below. A single window is visible just to the right of the curved damage section. Lower down a single rectangular opening is present to the left of the opening in the face. This opening is much taller than the windows visible above. Its shape indicates that it is one of the vents that spanned the 5<sup>th</sup> and 6<sup>th</sup> floors. Thus, the damage visible in the image spans the 5<sup>th</sup> to 8<sup>th</sup> floors.

There is insufficient information in the image to identify the exact horizontal location of the damage on the face. However, it is likely that the damage area is a downward extension of the opening visible in Figure 5–47 and Figure 5–49 to the immediate left of Column 20. If this is correct, the opening in this area extends from at least the 5<sup>th</sup> floor to the 15<sup>th</sup> floor.
