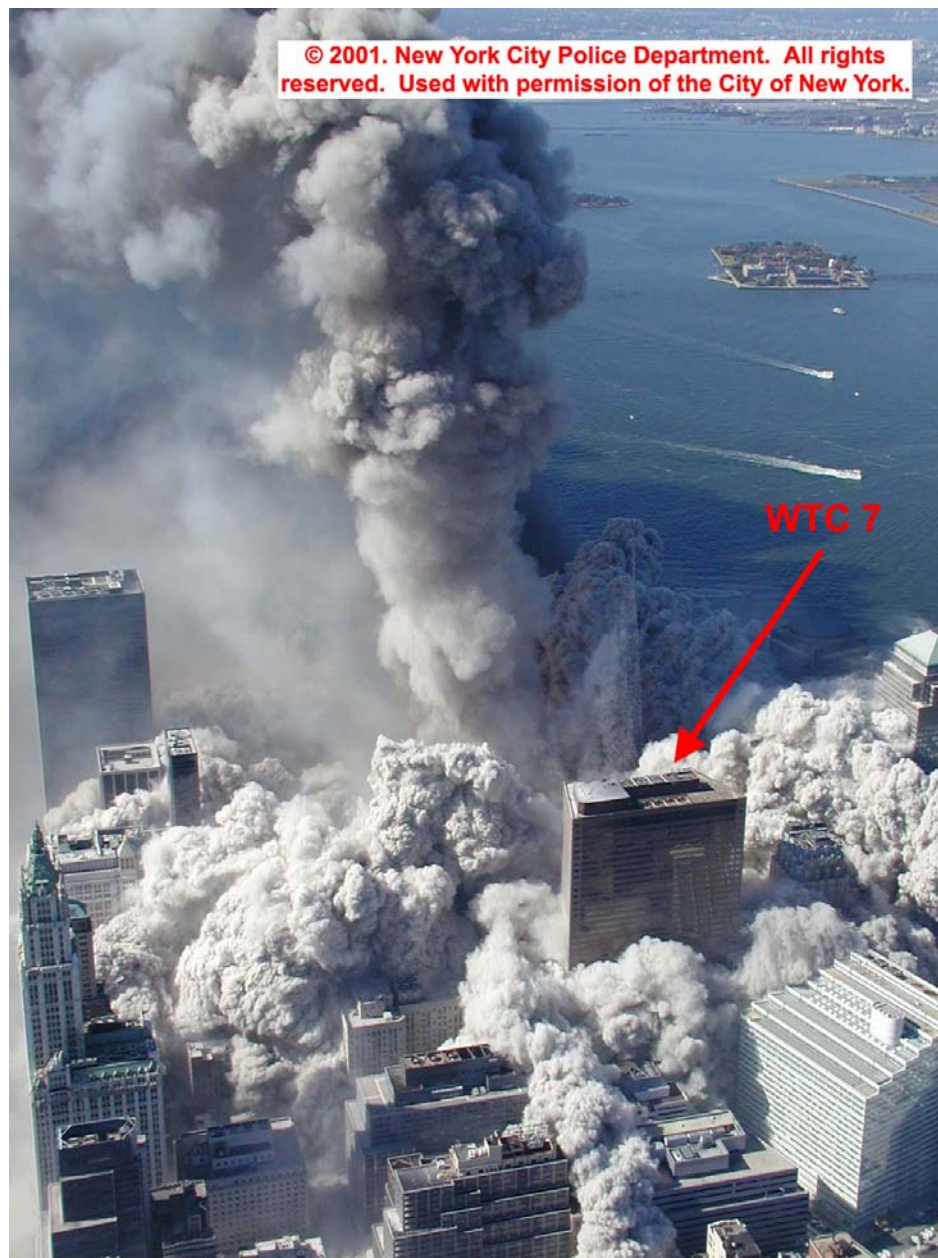
**Figure 5–103.**  
Photograph  
showing the dust-  
laden flows  
spreading away  
from WTC 1  
following its  
collapse.

It was taken 32 s  
after the start of the  
collapse.
