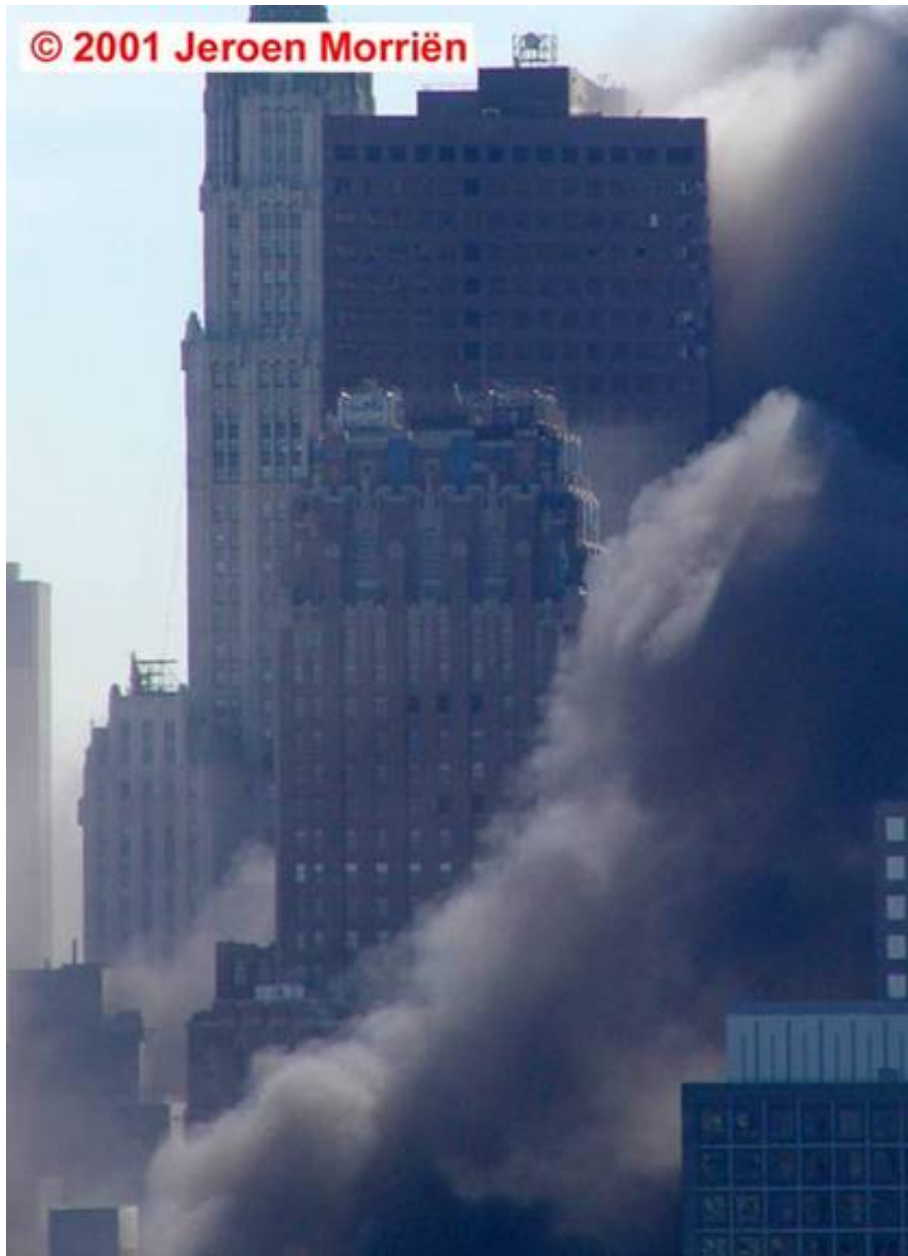
**Figure 5–105.**  
**Cropped photograph**  
**showing the west face**  
**of WTC 7, shot at**  
**11:13:51 a.m. from**  
**New Jersey looking**  
**across the Hudson**  
**River.**

The intensity levels  
have been adjusted.

Visual evidence indicates that the smoke plumes seen in Figure 5–104 and Figure 5–105 originated from vehicles that were ignited at numerous locations following the collapse of WTC 1. Several burned out vehicles can be seen on West Broadway between the east side of WTC 7 and the Post Office Building in Figure 5–90. Review of several photographs showed that there were at least six burned automobiles, two postal trucks, and a fire truck on this single block. Another view of West Broadway taken from one block further north near its corner with Park Place is shown in Figure 5–106. Multiple burned vehicles, including a bus, several cars, and trucks, are visible on the street between Park Place and Barclay Street. A second photograph taken much earlier from a location slightly closer to Barclay Street is shown Figure 5–107. In addition to the vehicles visible in these two images, other photographs of the area show that there were several additional burned out automobiles closer to Barclay Street. Nearly every vehicle on this block was ignited.
