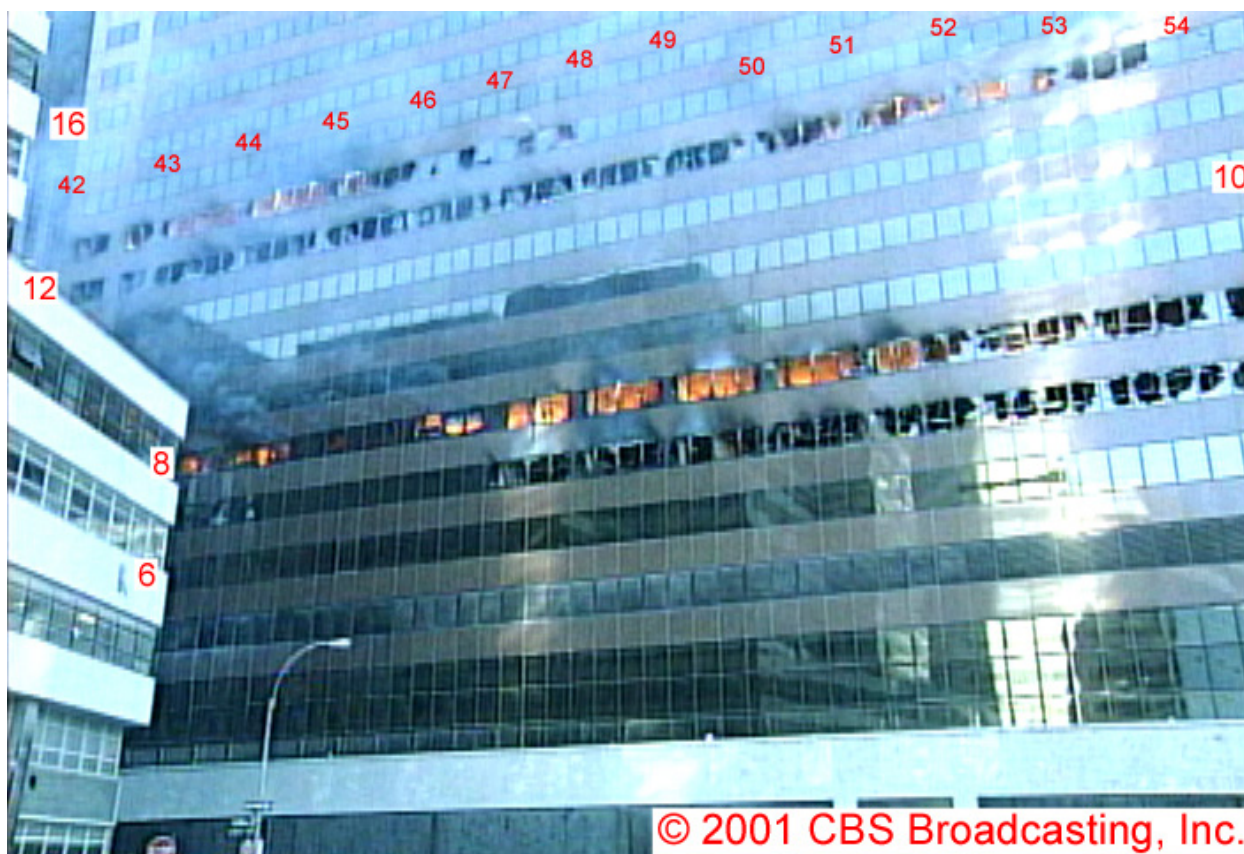
**Figure 5-136. Frame taken from a video shot from near the corner of Greenwich Street and Park Place showing the north face of WTC 7 between 3:49 p.m. and 3:54 p.m.**

The building on the left is 30 West Broadway. The intensities have been adjusted, and column and floor numbers have been added.

After leaving the lobby of 123 Barclay Street, the news crew moved out onto Greenwich Street, where they filmed the north face of WTC 7 from near the corner of Greenwich Street and Park Place. As before, the exact arrival time is unknown, but an assumed 5 min travel time yields an estimate somewhere between 3:49 p.m. and 3:54 p.m. Figure 5-136 shows a frame extracted from this video clip that provides a good head-on view of much of the 7<sup>th</sup>, 8<sup>th</sup>, 12<sup>th</sup>, and 13<sup>th</sup> floors. All of the open windows visible on the 7<sup>th</sup> floor are dark, providing additional confirmation that the fire that had spread as far as window 7-47A died down before covering the entire north face. A couple of the windows near Column 44 appear to have broken glass, but there are no indications of fire in this area.

The appearance of the windows on the 8<sup>th</sup> floor changed substantially between the times when the video frames shown in Figure 5-134 and Figure 5-136 were taken. At the earlier time, fire was visible as far east as window 8-47A, while in Figure 5-136, fire is not only apparent at the adjacent windows between Columns 46 and 47, but intense flames have appeared much further to the east in windows 43E to 44E. It is possible that the fire is even further to east, but these windows are hidden by the building in the
