### Fires on or below the 14<sup>th</sup> Floor, 4:40 p.m. to 5:21 p.m.

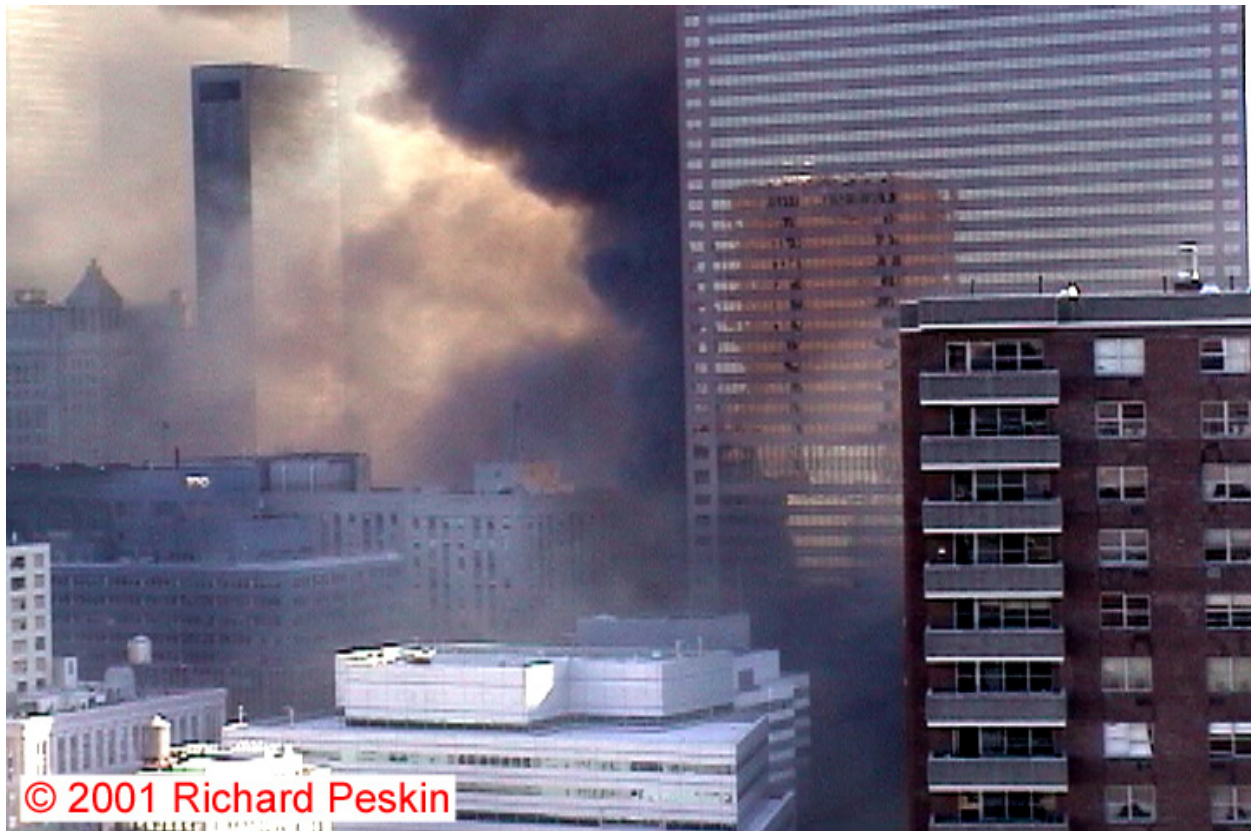
After roughly 4:40 p.m., imagery in the Investigation database showing the north face of WTC 7 is more limited. Figure 5–151 shows a long distance shot of the north face of WTC 7 taken at 4:52:24 p.m. from the same vantage point as Figure 5–147. In the video clip it can be seen that smoke is passing across the lower part of the north face. Unlike Figure 5–147, there is no fire visible on the north face from this distance. It seems the fires on the 11<sup>th</sup> floor have died down, but it is possible that fire was present, but hidden by the smoke. Heavy, dark smoke is still visible rising from the east face of the building.

**Figure 5–151. Frame from a video clip shot from the top of a nearby building, showing the north face of WTC 7 at 4:52:24 p.m.  $\pm$  1 s.**

The intensity levels have been adjusted.
