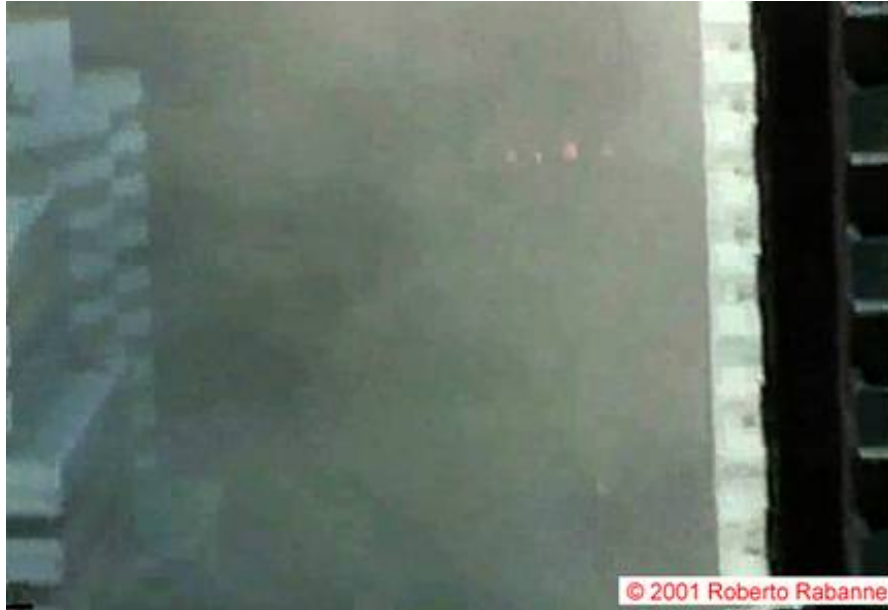
**Figure 5-156.** This frame from a video shot from a building to the northwest of WTC 7 was taken around 5:19:45 p.m. with an uncertainty of  $\pm 120$  s. The intensities have been adjusted.

Figure 5-139 indicates these windows lie around Columns 50 and 51 on the 11<sup>th</sup> floor. In the roughly 11 min between Figure 5-154 and Figure 5-156, the fires on this floor have continued to spread toward the west.
